**CITY OF OJAI URBAN WATERSHED
ASSESSMENT AND RESTORATION PLAN**
(CDFG CONTRACT NO. PO250014)

August 2005

David Magney Environmental Consulting. 2005. City of Ojai Urban Watershed Assessment and Restoration Plan (CDFG Contract No. PO250014). 8 August 2005. (PN 02-0151.) Ojai, California. Prepared for the City of Ojai, California, and California Department of Fish and Game, Sacramento, California.

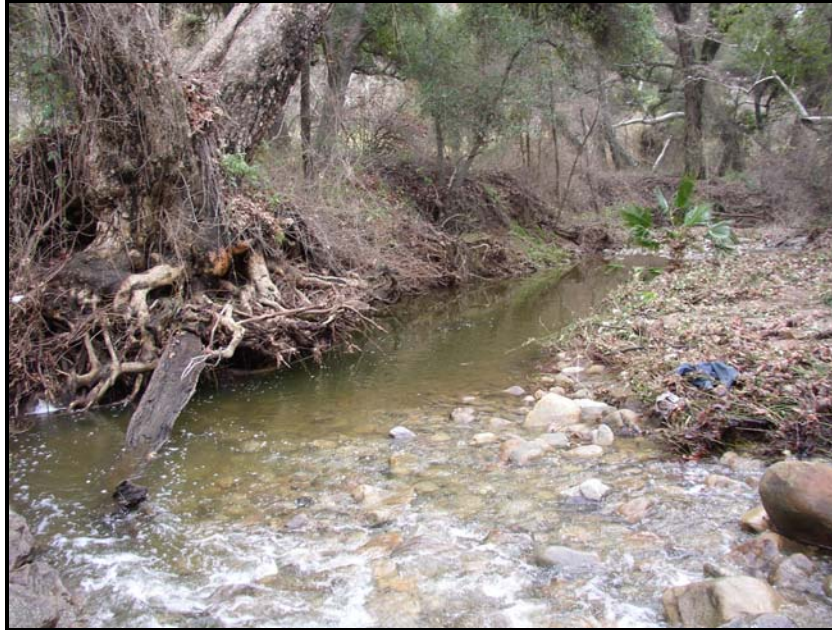
Photograph 6. Stewart Canyon Creek showing root wads and logs as functional instream cover for Steelhead (5 January 2005). A Southern Steelhead was observed at this location in December 2004.

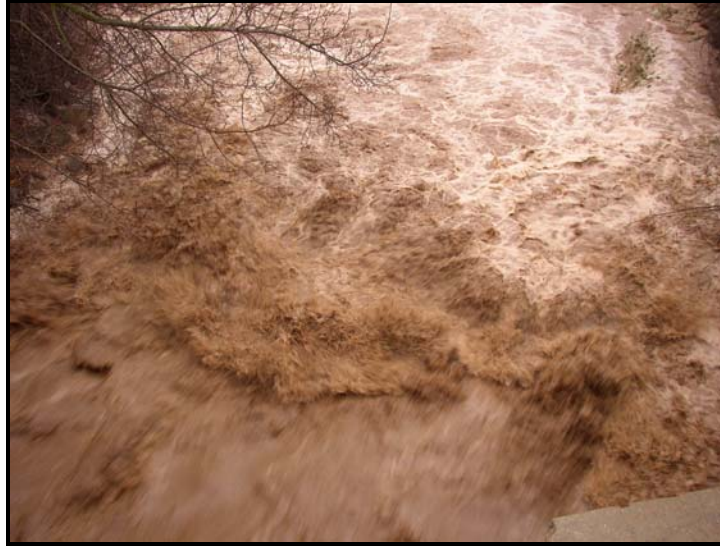
Photograph 13. Thacher Creek at Boardman Road during winter storm creating elevated levels of turbidity (9 January 2005).

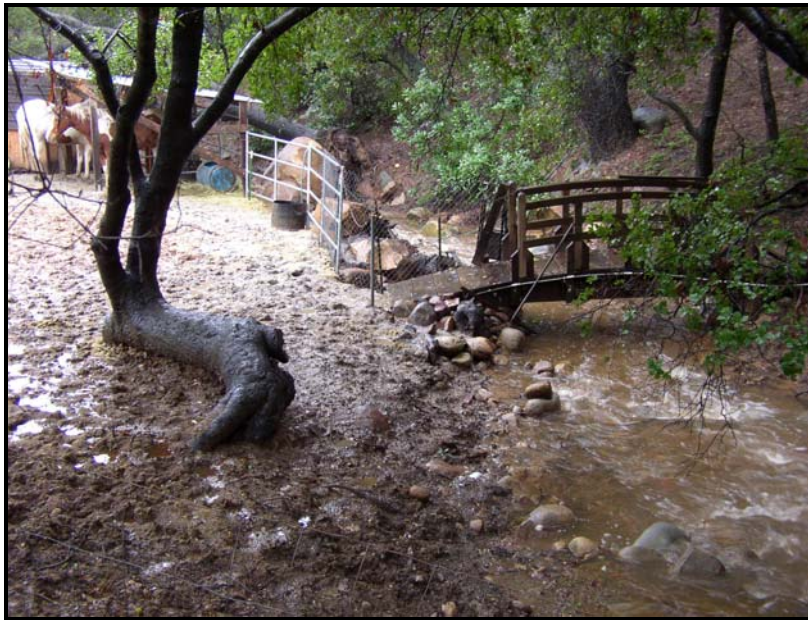
Photograph 15. Showing close proximity of horse corral to the active creek channel creating a significant input of horse manure and urine (8 January 2005).

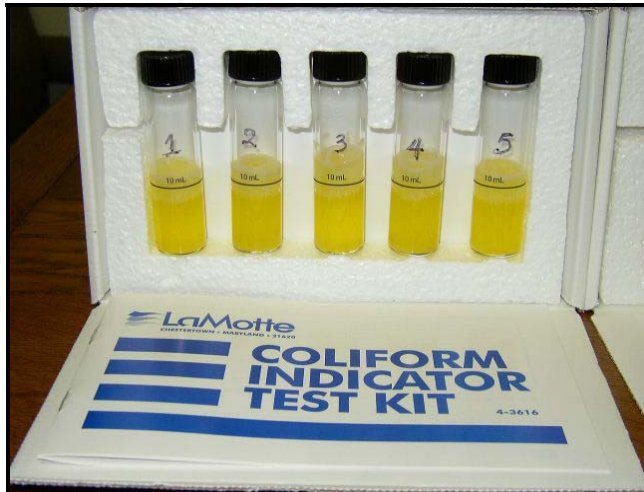
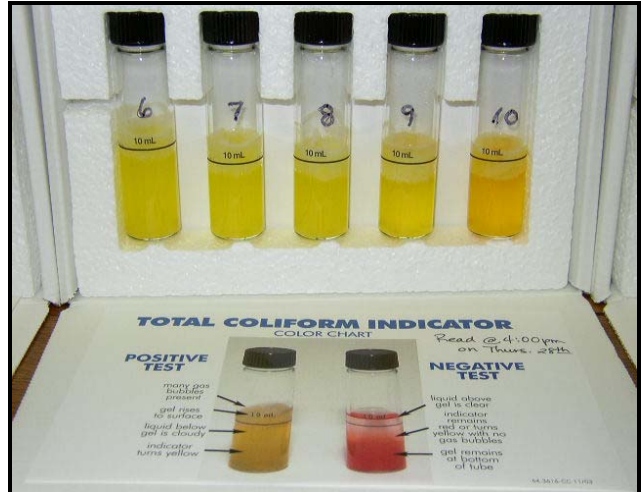
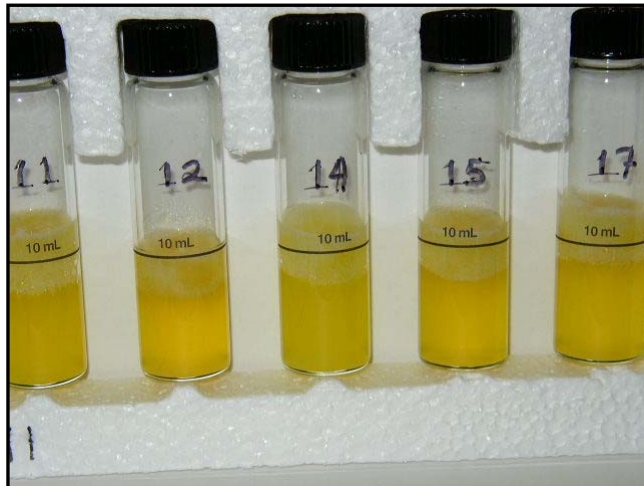
Photograph 16 (top left). Positive coliform indicator results for Water Quality Sampling Stations 1 through 5. **Photograph 17** (top right). Positive coliform indicator results for Water Quality Sampling Stations 6 through 10, and showing the color chart for reading positive and negative results. **Photograph 18** (lower left). Positive coliform indicator results for Water Quality Sampling Stations 11, 12, 14, 15, and 17 (no water was present at Station 13 and 16; therefore, no sample was collected). Photos taken 28 October 2004.

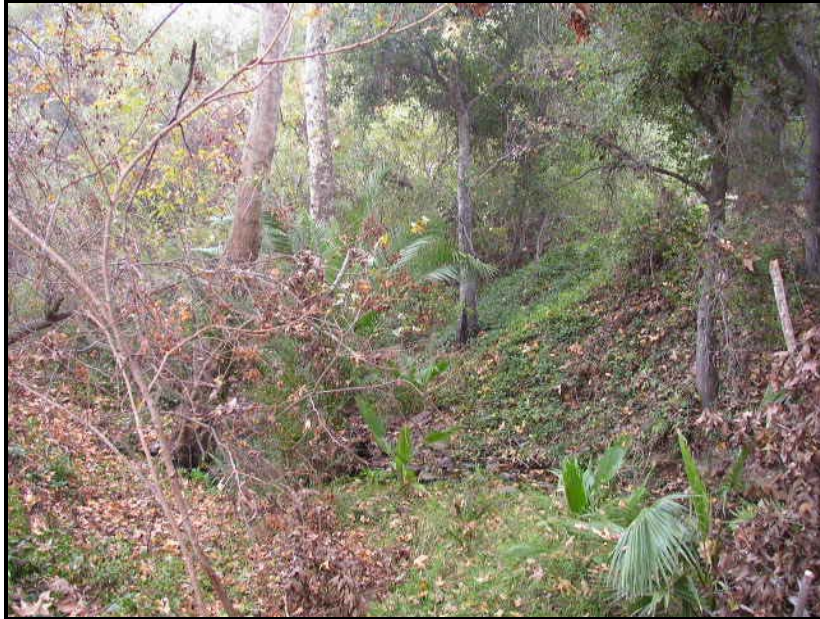
Photograph 27. Fox Canyon Barranca showing California Sycamore Series with oaks and willows, and showing influence of invasive exotic plant species (27 November 2004).

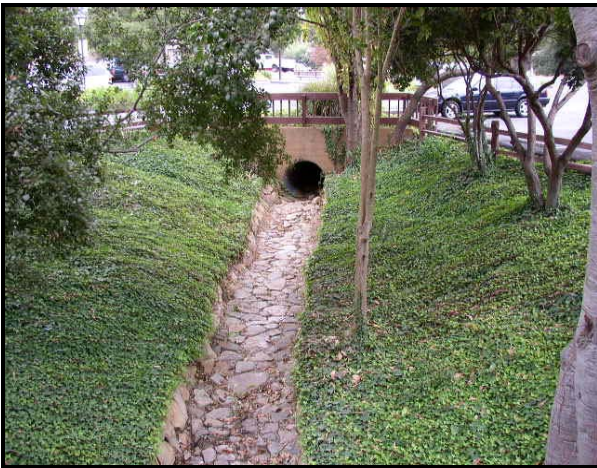
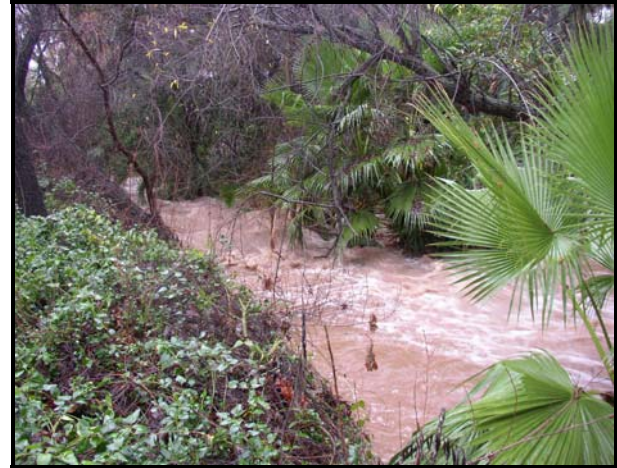
Photograph 32 (left). Arbolada Creek, view south showing planted ornamentals prohibiting the establishment of native riparian propagules (30 September 2004). **Photograph 33** (right). Fox Canyon Barranca along S. Montgomery Street showing dominance by escaped ornamentals such as Mexican Fan Palm (9 January 2005).

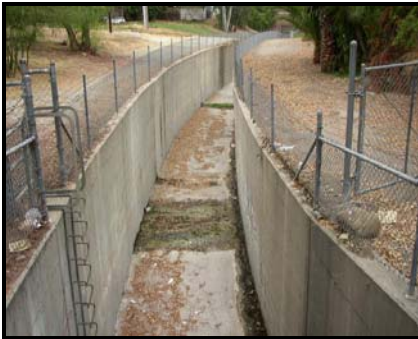
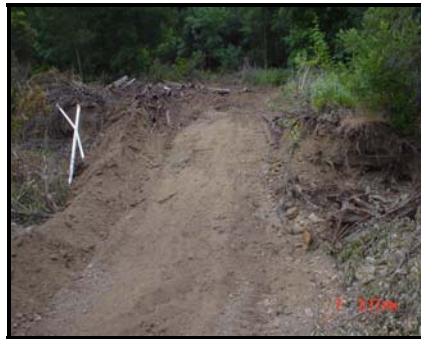
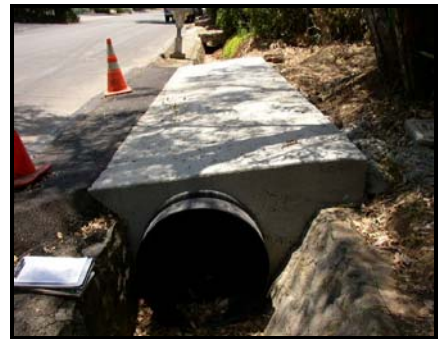
Photograph 43 (left). Lower open portion of Stewart Canyon Creek flood channel.
Photograph 44 (middle). Fire-fighting activities that damaged aquatic habitats on San Antonio Creek.
Photograph 45 (right). Example of undersized culvert for driveway entrance.

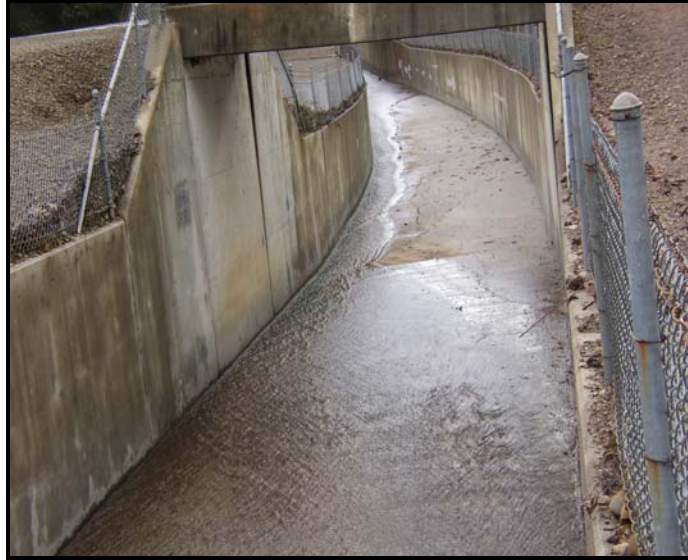
Photograph 48. Stewart Canyon Creek showing example of impervious surface (28 January 2005).

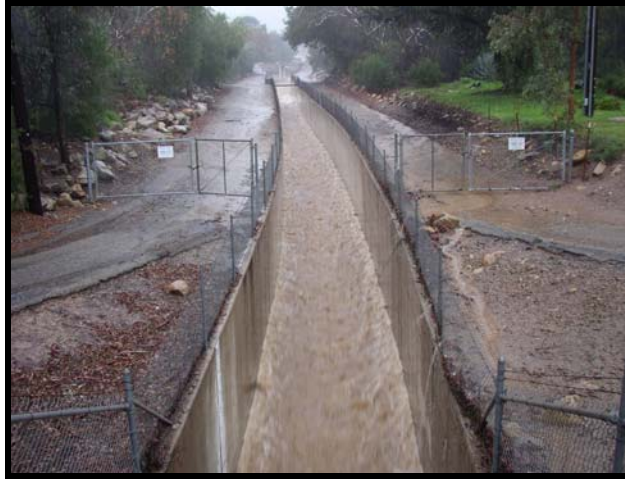
Photograph 82 (left). Stewart Canyon Creek Reach 5 with functional riparian habitat (24 January 2005).
Photograph 83 (right). Stewart Canyon Creek channelized Reach 4 showing peak flows during winter storm, view north (9 January 2005).

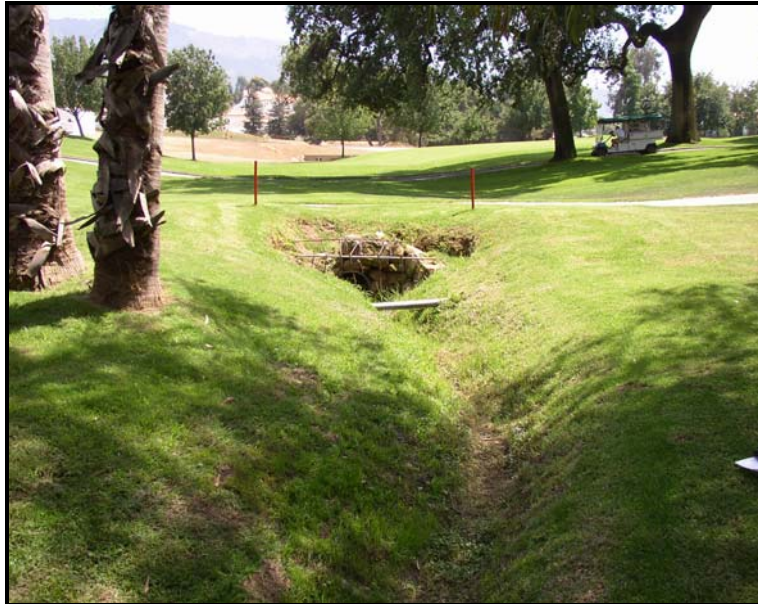
Photograph 94. Del Norte Creek through golf course; creek conditions lack buffer between the stream and golf course turfgrass. Using native Saltgrass here would be preferable rather than the existing high water-demanding grasses.
