CREEK ROAD REPAIRS

NATURAL ENVIRONMENT STUDY

**Natural Environment Study
for Creek Road Repair Project,
Ojai, Ventura County
(Caltrans Project No. ER-4205[003])**

7-VEN-0-OJI-0.8 km (0.5 mi) S of SR150 MP 28.3

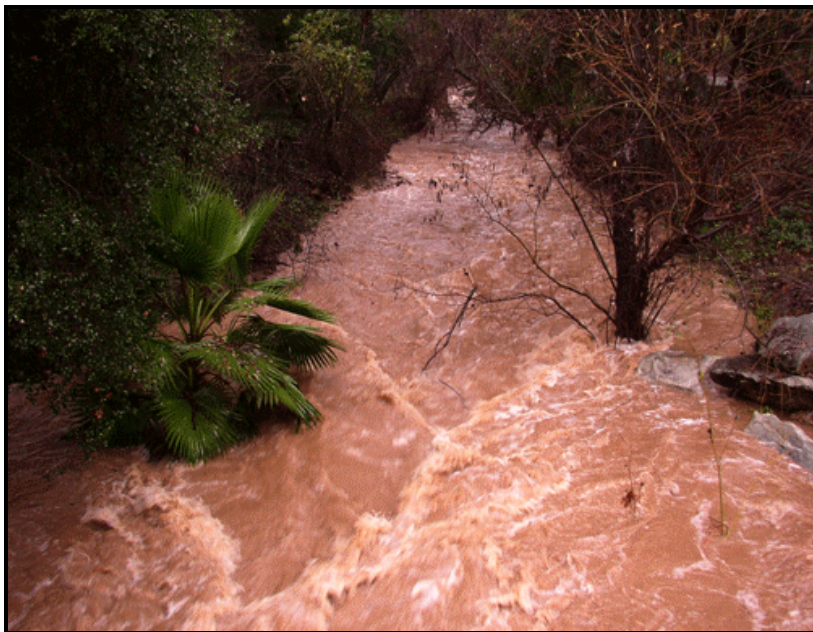
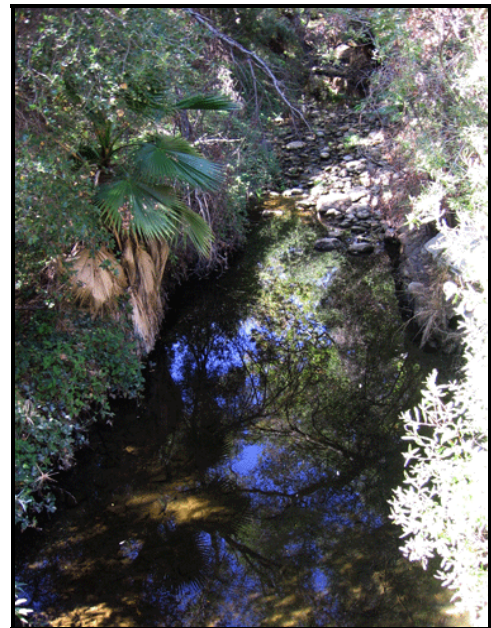
*Photo 1 (left) - Stewart Canyon Creek at Creek Road bridge on 9 January 2005.
Photo 2 (right) - Stewart Canyon Creek at same location on 17 October 2007.*

Portions of the shoulder of Creek Road adjacent to Stewart Canyon Creek near the City’s southern boundary are subject to erosion during high storm flows in the creek, which occurred most recently in 2005. Rock riprap and pipe and wire protection have been placed along the stream bank adjacent to the road’s western shoulder in the sections most affected by erosion to prevent damage to the road. These sections have continued to erode and the protective elements are currently in need of repair in order to restore them to a condition adequate to protect Creek Road.

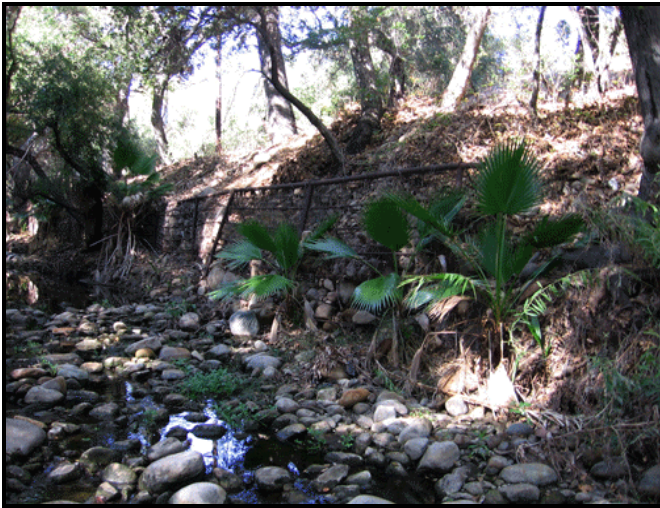
Photo 3 - Worksite 1, view upstream from creek bed. Photo 4 - Worksite 2, view upstream from top of bank.

Construction Prescription ¹	Approximate Linear Extent of Repair	Stream Reach	Approximate Linear Extent of Diversion
1. Place ¼-ton rocks at toe of existing pipe and wire and backfill wire with facing rock	33.5 m (110 ft)	Lower	67 m (220 ft)
2. Repair existing rock riprap as needed	18.3 m (60 ft)		
3. Extend riprap to join exposed bedrock	4.6 m (15 ft)		
4. Place ¼-ton rocks at toe of existing pipe and wire as needed	53.3 m (175 ft)	Middle	61 m (200 ft)
5. Restore bank rock facing with ¼-ton rocks	13.7 m (45 ft)	Upper	18 m (60 ft)
6. RegROUT existing 12” PVC drain outlet	N/A	Lower	N/A

The reach of Stewart Canyon Creek adjacent to the Creek Road repair site is described as a pool and riffle stream with perennial flow in a defined channel. The streambed and banks are generally in a natural state except for the sections with riprap and other materials that fortify portions of the eastern bank along Creek Road (see Figure 3 and Photos 3 through 8). Instream cover consists of overhanging

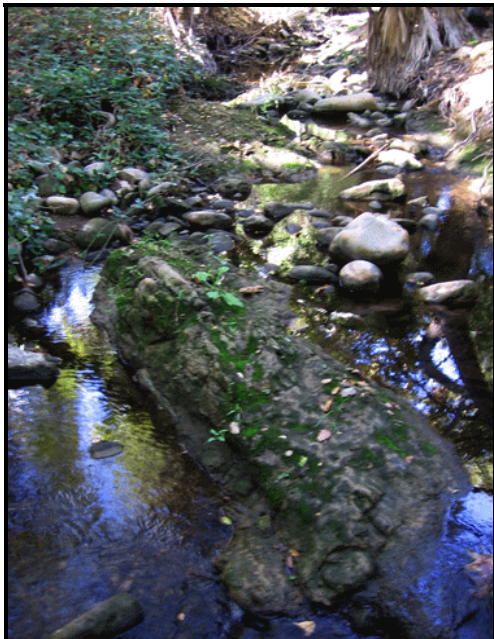
Photo 5 - Worksite 3, view upstream of bedrock. Photo 6 - Worksite 4, pipe and wire revetment.

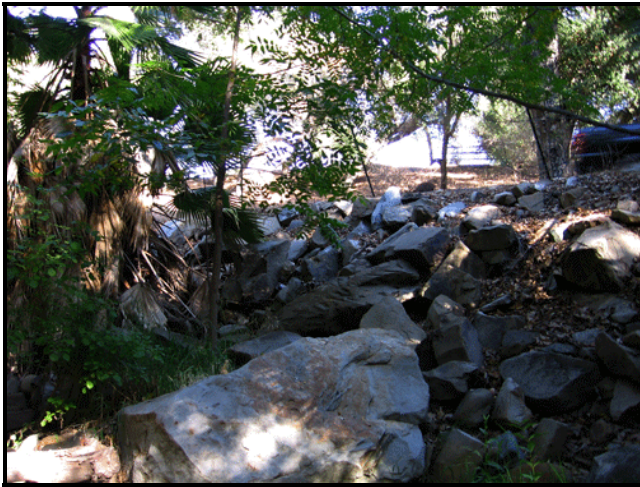
Photo 7 - Worksite 5, view upstream of eroded riprap. Photo 8 - Worksite 6, 12" drainpipe and eroded grout.
