SECTION IV. METHODOLOGY

This section provides the methods used by David Magney Environmental Consulting (DMEC) to delineate waters of the U.S., including wetlands, at the Lyons Canyon Ranch project site. Section III includes a discussion of the general delineation approach, lists the references cited and followed for habitat classification, and provides a detailed analysis of the wetland delineation criteria assessed by DMEC biologists.

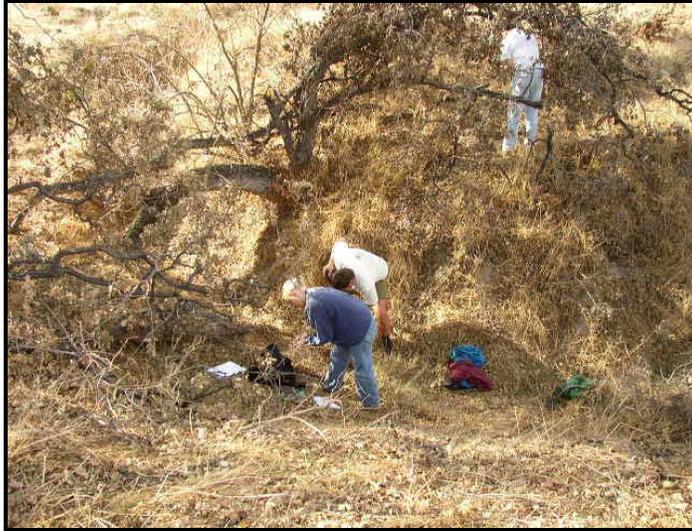
Lyons Canyon Creek, 10 December 2003, DMEC delineating Transect B plots.

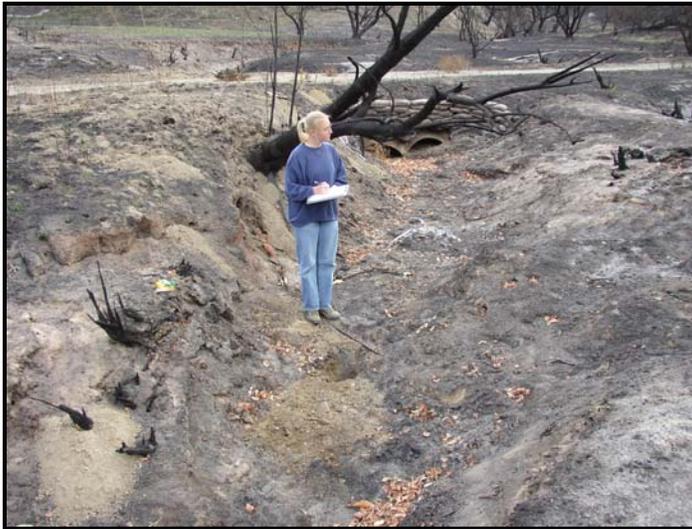
Lyons Canyon Creek, 10 December 2003, DMEC delineating Transect I plots.

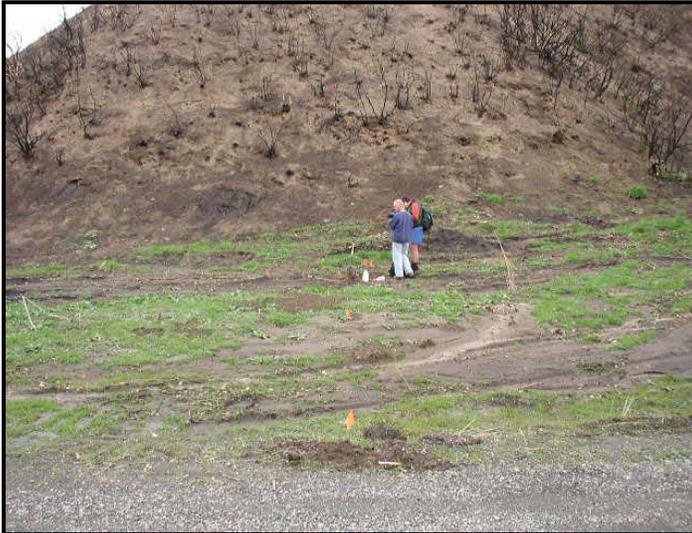
Lyons Canyon Ranch, 23 February 2004, DMEC delineating Transect BT plots.

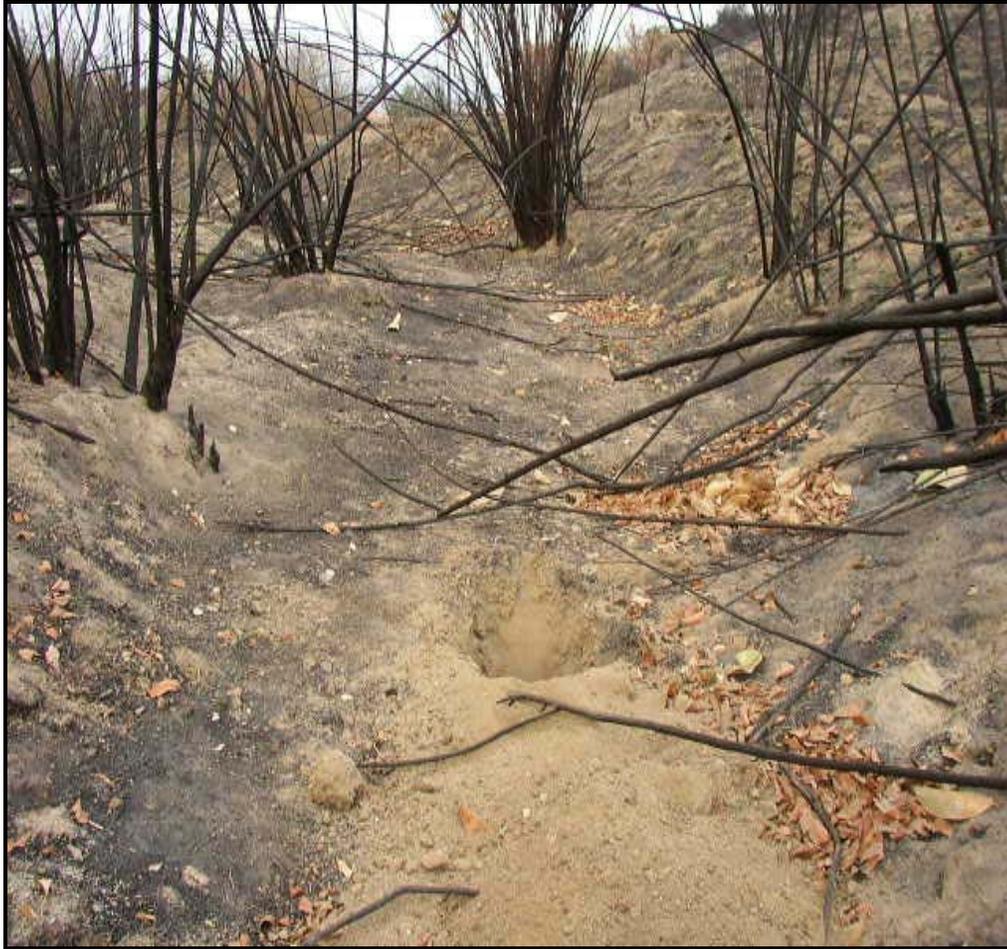
Burned *Baccharis salicifolia* (Mulefat - FACW) in Lyon Canyon Creek, 10 December 2003, Transect K.

The Lyons Canyon project site is determined to be in an “Atypical Situation” for determining wetlands as a result of the October 2003 Simi Wildfire, which has significantly altered the vegetation onsite. The fire has burned all vegetation onsite and has at least temporarily, eliminated several species from the project site. Several plant species remaining onsite after the fire (mostly only stumps and stems) are unidentifiable to the genus level. Furthermore, the (re)sprouting perennial herb stems and shrub stumps, and sprouting annual herb/grass seedlings, observed onsite are predominantly unidentifiable. This alteration to the vegetation onsite has created a situation where positive indicators for hydrophytic vegetation determinations are absent due to the significant natural vegetation clearing. Hydrophytic plant species are not being represented onsite as they would have been prior to the wildfire/disturbance. In addition, various activities have altered the soils and hydrology in a few locations onsite. This alteration may have created a situation that hinders positive indicators for hydric soil determinations, due to soil layers being buried or significantly altered. Most of the recent disturbance activities appear to have been related to fire fighting activities in late October 2003.
