ADJACENT LAND USES

IMPERVIOUS COVER

BARRIERS/FACTORS CAUSING HABITAT DEGRADATION

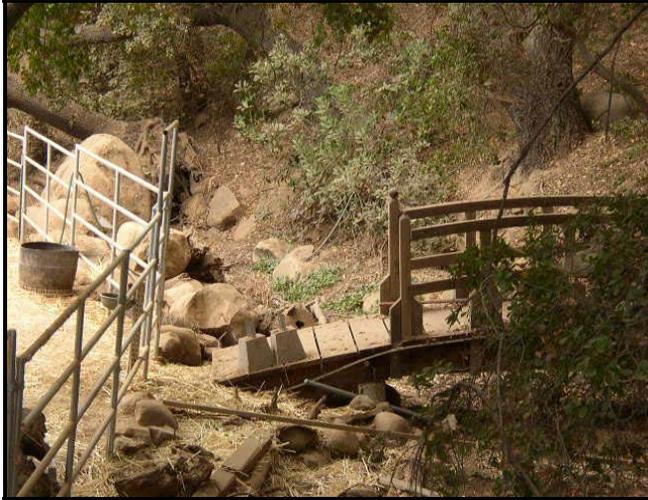
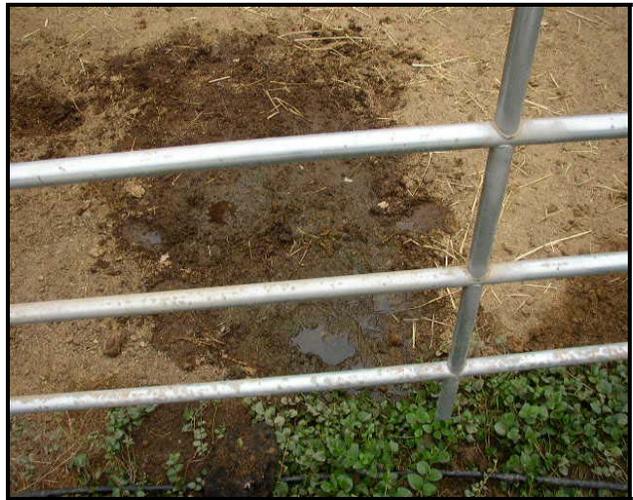
Photograph 41 (left). View of horse corral next to creek channel.
Photograph 42 (right). View of horse urine and manure within 25 feet of creek.

Horse Boarding. The Ojai Valley has long been a popular place to enjoy horseback riding and other equestrian activities. Many horse owners keep their horses on their own property, while others have their horses boarded at commercial facilities. While horse manure is much less toxic than other pet wastes such as feces from dogs and cats, it is nevertheless a source of coliform bacteria, one of the pollutants found in our stream sampling tests. The presence of coliforms is widely recognized as an indicator of water quality in natural streams.

Because individual horse boarding on private land does not require a permit, it was not possible to easily or efficiently locate these parcels on a map or to quantify the number of horses boarded in and around Ojai. However, neighborhoods in Ojai with larger parcels are where horse corals are located within the City, and are generally lacking on parcels less than 1 acre in size. Those neighborhoods in Ojai that are known to contain corals for one or more horses include: Arbolada, Del Oro, north Foothill Road, N. Montgomery, Persimmon Hill, and Gridley Road.

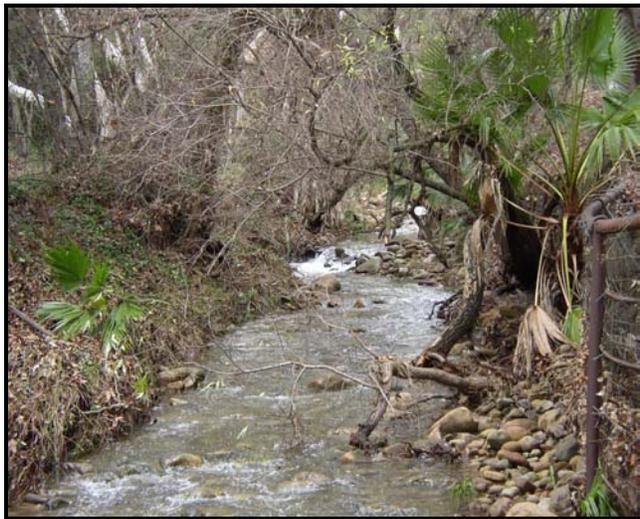
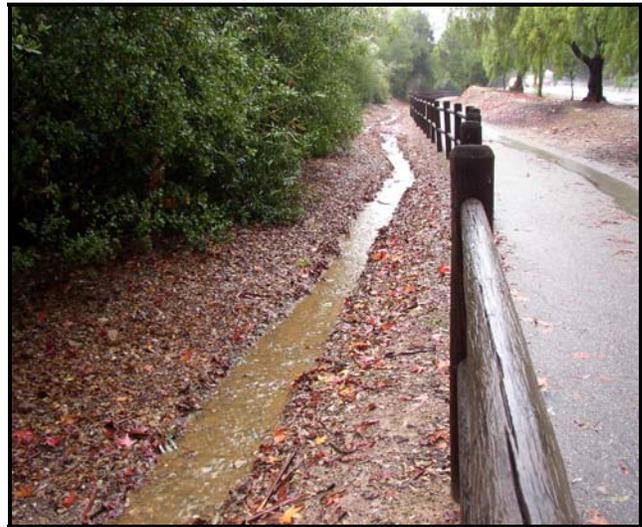
*Photograph 46 (left). Stewart Canyon Creek showing example of natural surface (5 January 2005).
 Photograph 47 (right). Watershed drainage to Villanova Creek showing example of compacted surface (8 January 2005).*

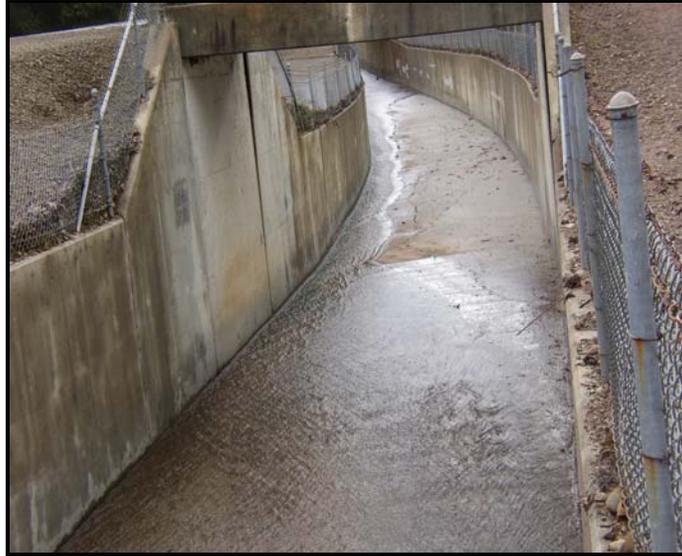
Photograph 48. Stewart Canyon Creek showing example of impervious surface (28 January 2005).

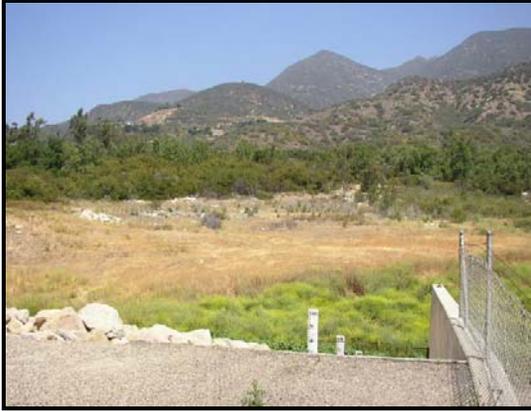
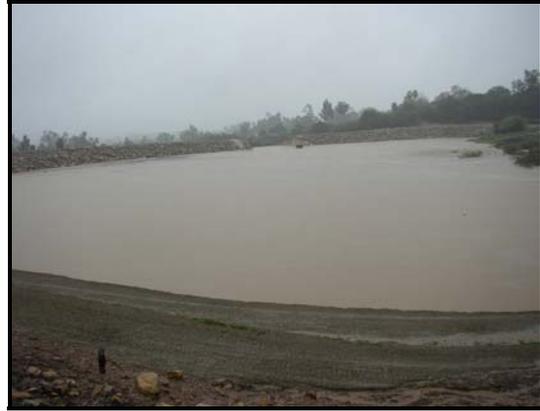
Photograph 49 (left). Stewart Canyon Debris Basin empty during spring and summer months (27 May 2004).
Photograph 50 (right). Stewart Canyon Debris Basin filled after winter storm event (9 January 2005).

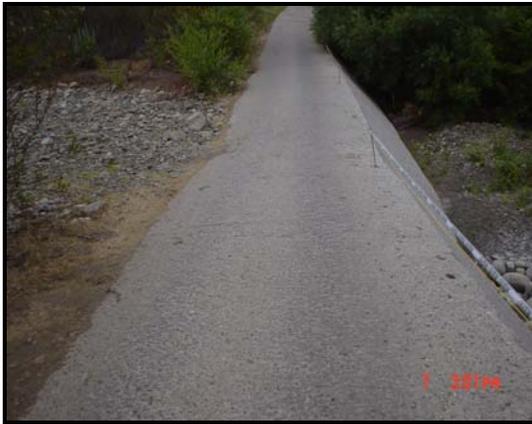
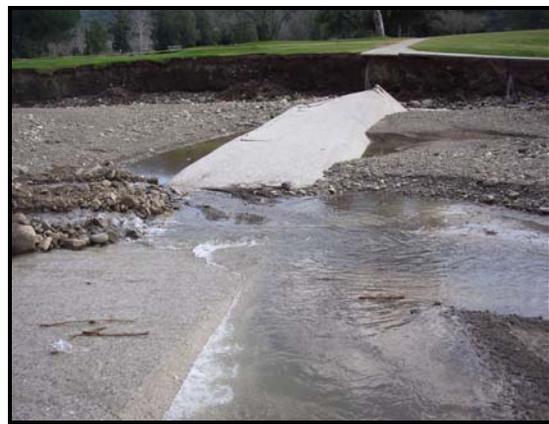
Photograph 51 (left). San Antonio Creek Arizona Crossing at Soule Park Golf Course creating a major barrier to Steelhead (16 July 2004). **Photograph 52** (right). San Antonio Creek Arizona Crossing at Soule Park Golf Course was washed out and buried by sediment during significant winter storm (8 February 2005).

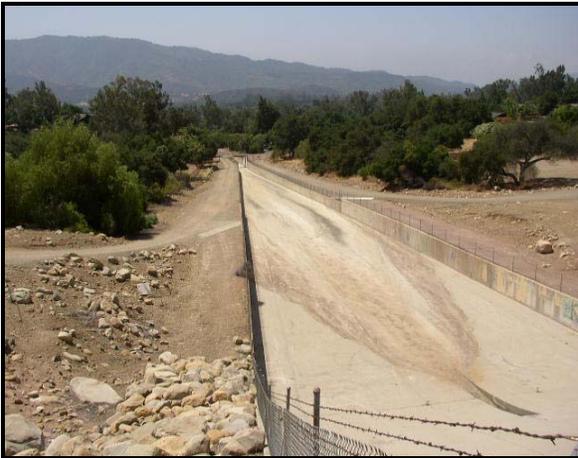
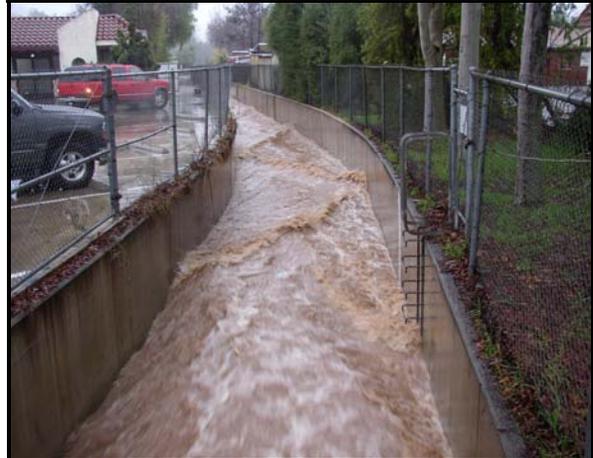
Photograph 53 (left). Stewart Canyon Creek showing aboveground flood control concrete channel (27 May 2004).
Photograph 54 (right). Fox Canyon Barranca showing meander pattern in concrete channel (9 January 2005).

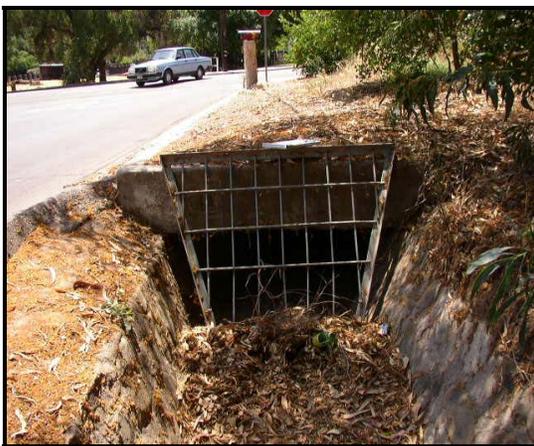
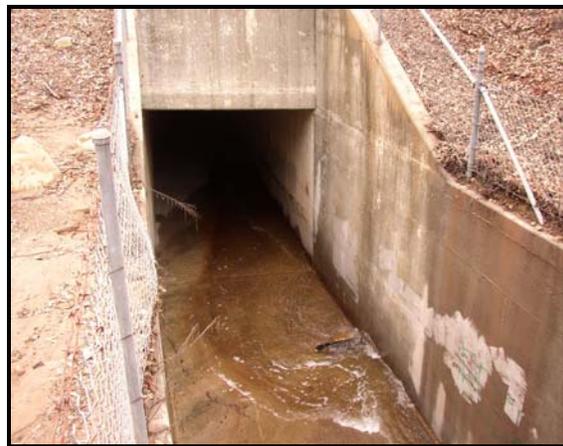
Photograph 55 (left). Undergrounding of Ojai Creek (27 May 2004). **Photograph 56** (right).
Undergrounding of Stewart Canyon Creek by a flood control channel and box culvert (8 January 2005).

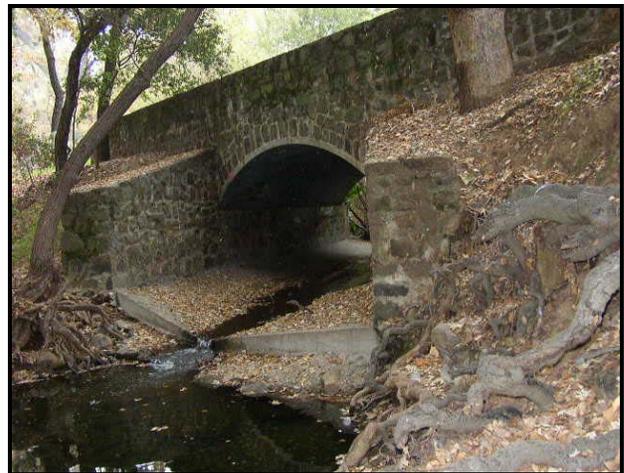
Photograph 58 (right). Fox Canyon Barranca bridge with cement floor at North Ventura St. (27 November 2004).

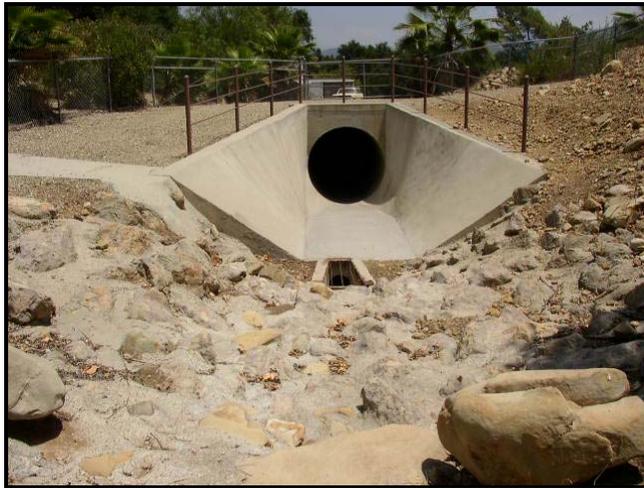
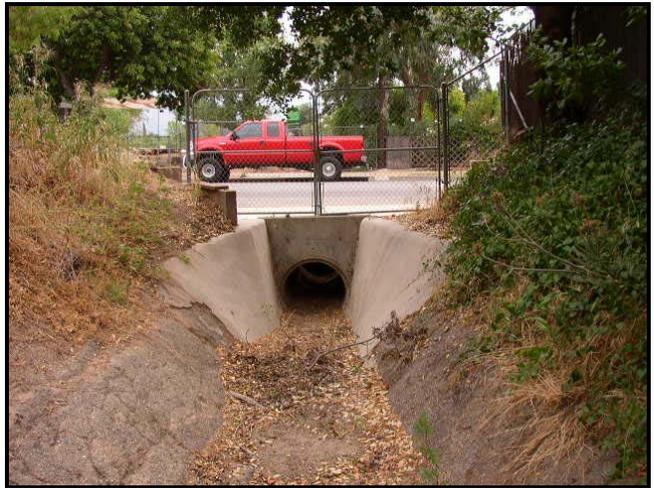
Photograph 59 (left). Fox Canyon Barranca underground intake (non-road) culvert, view downstream (27 May 2004).
Photograph 60 (right). Grandview-Park Drain road culvert (27 May 04).

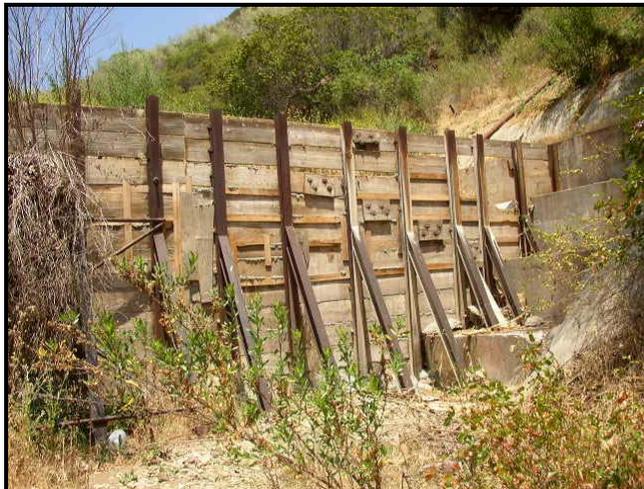
Some other barriers found throughout the City of Ojai include pipe diameter changes, upstream mitigation blockages, the Fox Canyon Barranca Debris Dam (Photograph 61), and Stewart Canyon Creek Debris Basin Standpipe (Photograph 62). These barriers are shown below in Figure 24, Map of Other Barriers in the City of Ojai.

Photograph 61 (left). Fox Canyon Barranca Debris Dam (27 May 2004).
Photograph 62 (right). Stewart Canyon Creek Debris Basin Standpipe (27 May 2004).
