**CITY OF OJAI URBAN WATERSHED
ASSESSMENT AND RESTORATION PLAN**
(CDFG CONTRACT NO. PO250014)

August 2005

David Magney Environmental Consulting. 2005. City of Ojai Urban Watershed Assessment and Restoration Plan (CDFG Contract No. PO250014). 8 August 2005. (PN 02-0151.) Ojai, California. Prepared for the City of Ojai, California, and California Department of Fish and Game, Sacramento, California.

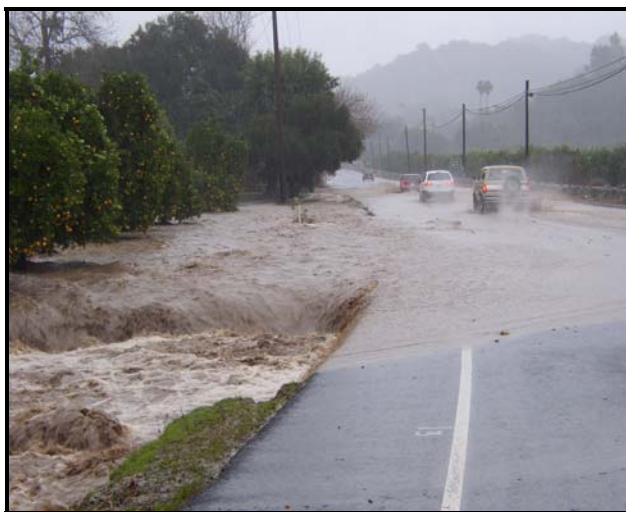
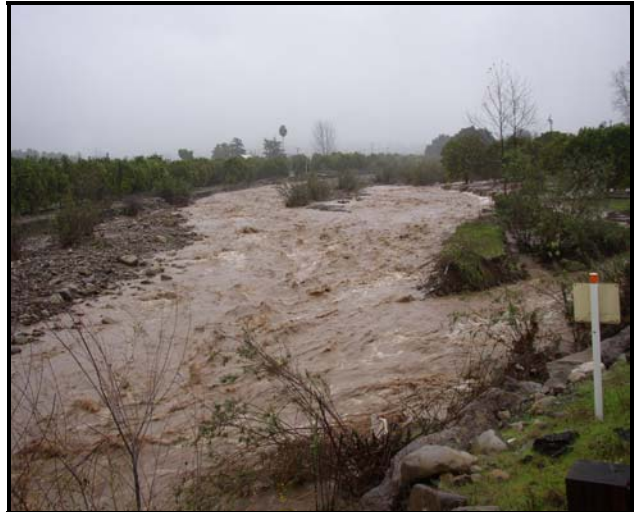
Photograph 1 (left). *Overflow of Thacher Creek on Ojai Avenue during winter storm event (5 January 2005).*
Photograph 2 (right). *San Antonio Creek during winter storm event (9 January 2005).*

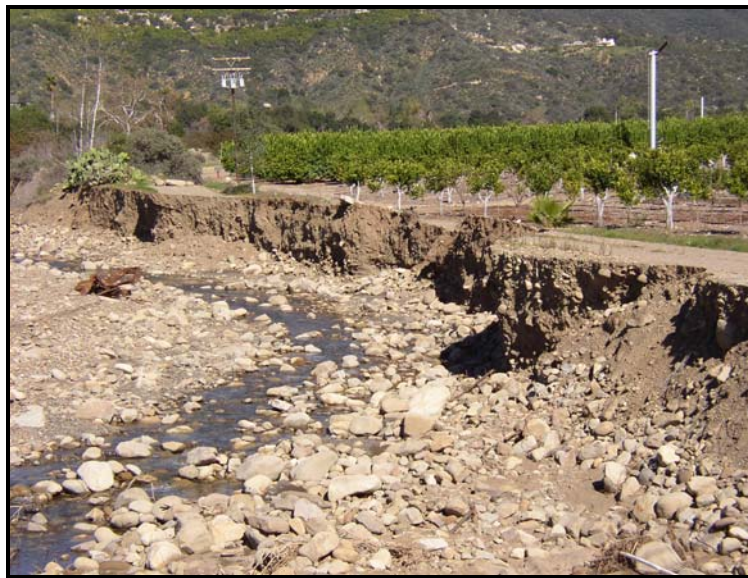
Photograph 3. San Antonio Creek above Grand Avenue showing natural channel morphology finding its course (4 February 2005).

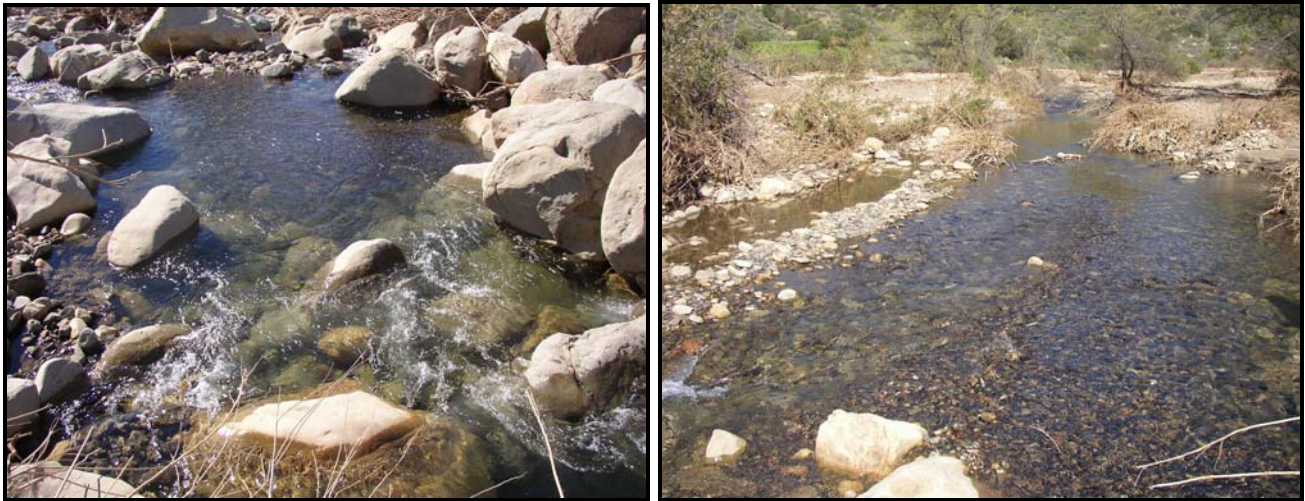
Photograph 4 (left). San Antonio Creek showing a riffle-pool-riffle stream type.
Photograph 5 (right). San Antonio Creek showing a run stream type. Photos taken on 4 February 2005.

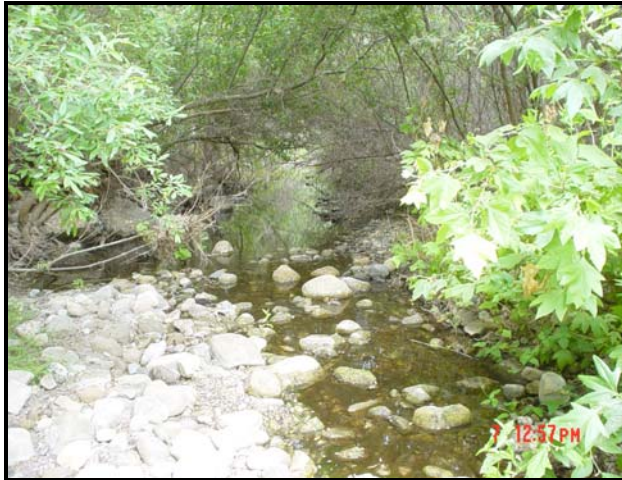
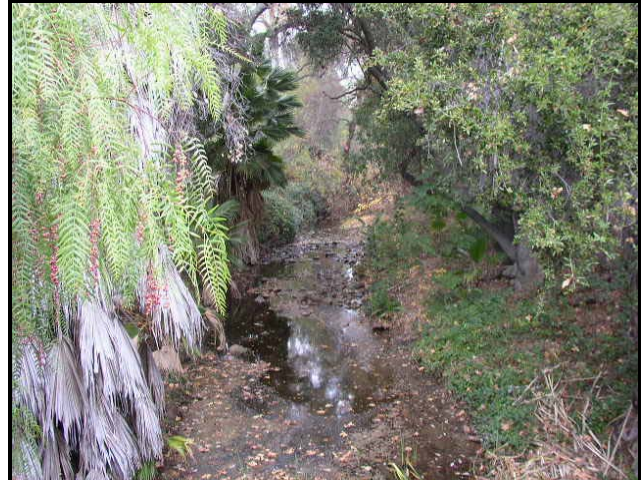
Photograph 7 (left). San Antonio Creek showing functional riparian habitat consisting of predominantly native plant species (17 June 2004). **Photograph 8** (right). Fox Canyon Barranca showing poor quality stream habitat dominated by invasive exotics and ornamental plant species, such as Peruvian Peppertree and Mexican Fan Palm (27 November 2004).

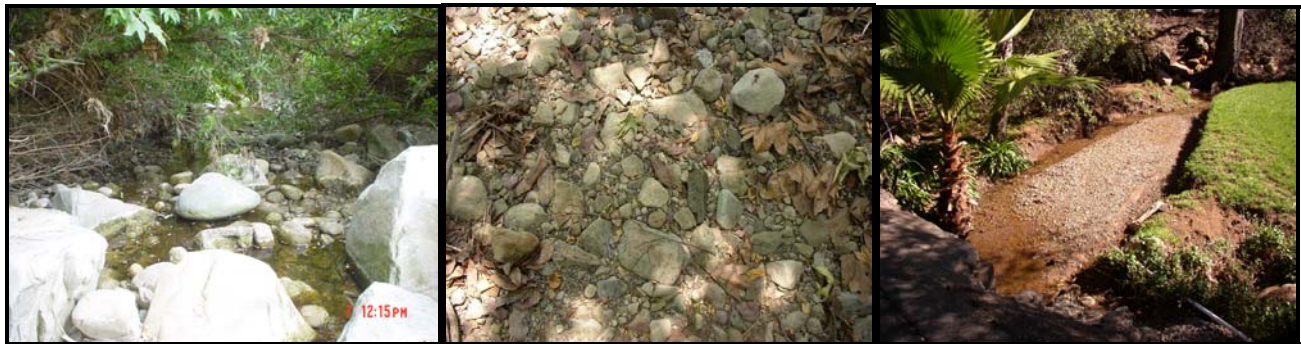
Photograph 9 (left), *Boulders in San Antonio Creek (17 June 2004).* ***Photograph 10*** (middle), *Cobbles in Fox Canyon Barranca (27 May 2004).* ***Photograph 11*** (right), *Gravels in Arbolada Creek (1 February 2005).*

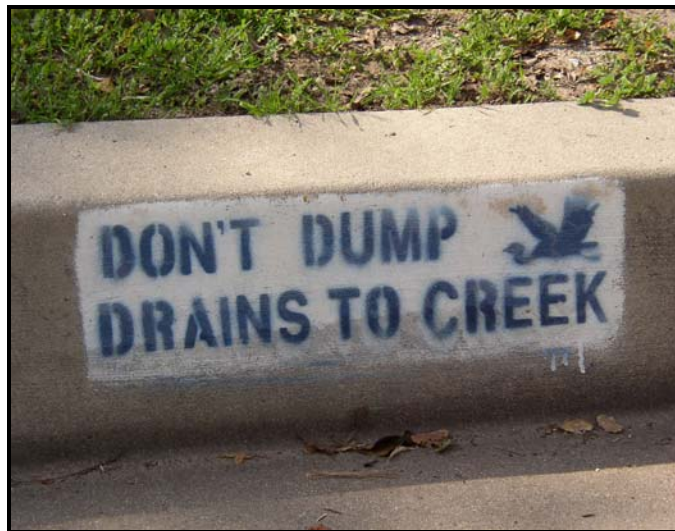
Photograph 12. Freshly painted “Don’t Dump” sign on a Daly Road curb.

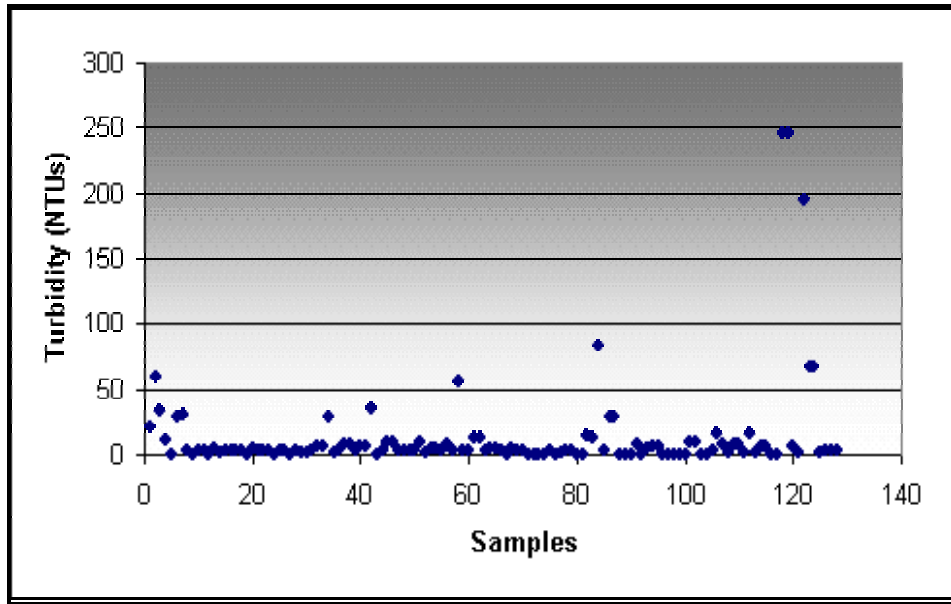
Figure 11. Scatter Plot of Turbidity Results for the Ojai Streams

Figure 11, Scatter Plot of Turbidity Results for the Ojai Streams, shows the turbidity level pattern of all samples taken at all stations over several dates in the creeks of Ojai. Note: samples that fall to “0 NTU” are readings from dry creeks. The significantly high readings are a result of sampling conducted during the storms of the 2004/2005 winter season.

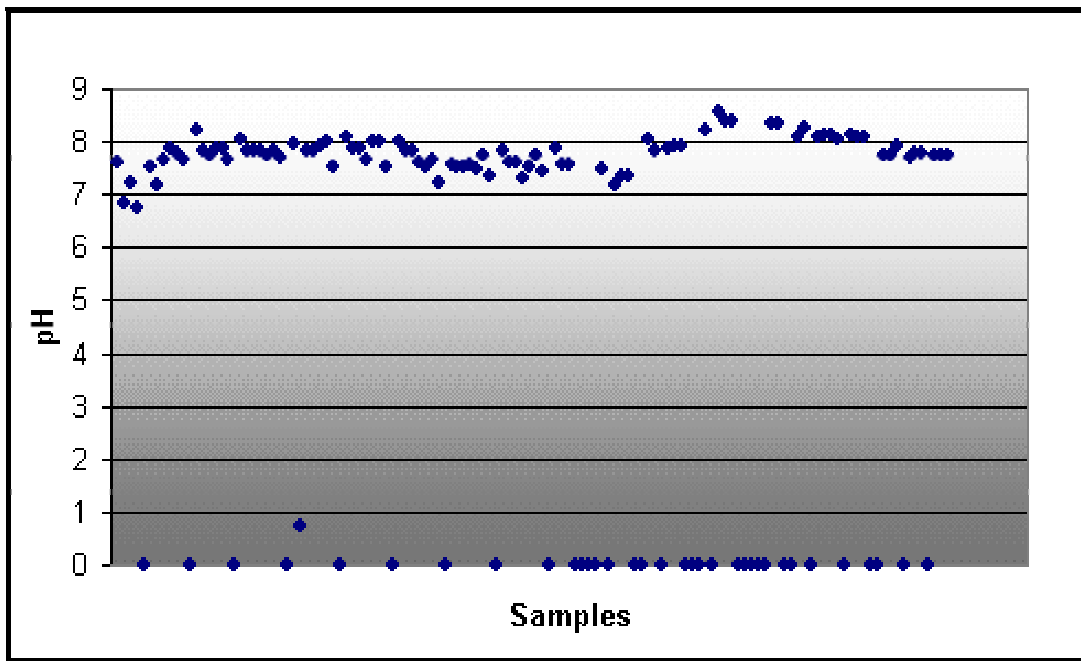
Figure 12. Scatter Plot of *pH* Results for the Ojai Streams

The range of *pH* for all measurements from all 19 stations (excluding zero values from dry creeks) over several dates is recorded between 6.77 at Station 1 (Happy Valley Reach 1) and 8.57 at Station 12 (San Antonio Reach 3). This Station 12 is the only station (and has only one date) that has a *pH* over the recommended 8.5. However, all stations have an average *pH* that is within the 6.5 to 8.5 threshold (Tables 17A & 17B; Appendix B). Figure 12, Scatter Plot of *pH* Results for the Ojai Streams, shows the *pH* level pattern of all samples taken at all stations over several dates in the creeks of Ojai. Note: samples that fall to “0” are readings from dry creeks.

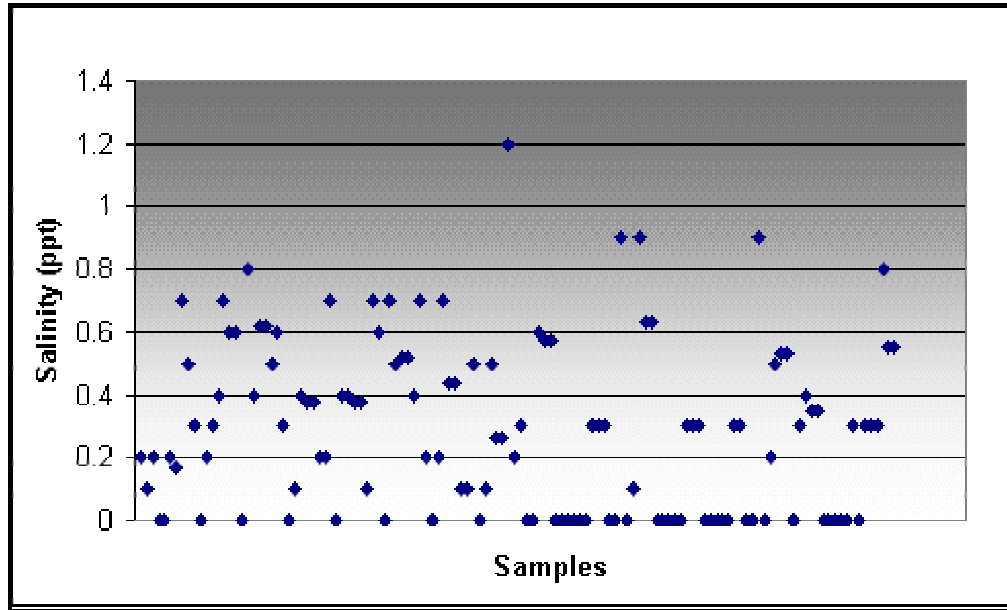
Figure 13. Scatter Plot of Salinity Results for the Ojai Streams

Figure 13, Scatter Plot of Salinity Results for the Ojai Streams, shows the salinity level pattern of all samples taken at all stations over several dates in the creeks of Ojai. Note: samples that fall to “0 ppt” are readings from creeks that were dry.

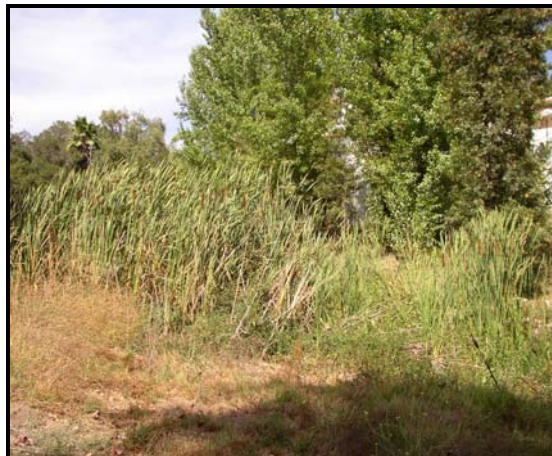
Photograph 22. Del Norte Creek Reach 1, view north showing Cattail Series in the foreground (19 August 2004).

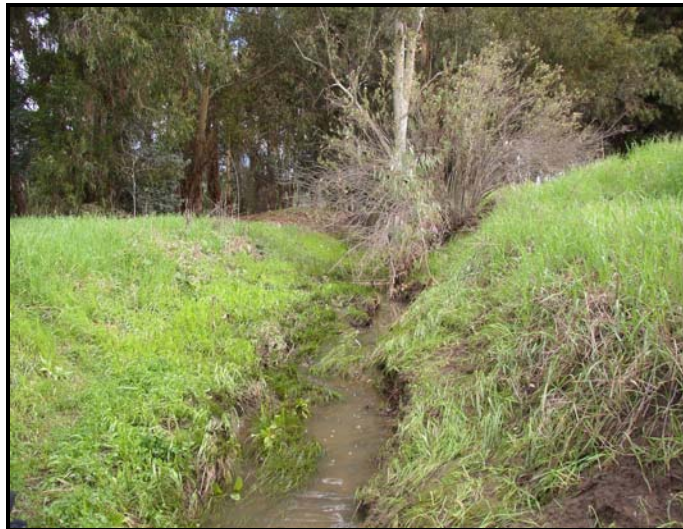
Photograph 23. Nordhoff Drain showing California Annual Grassland (5 January 2005).

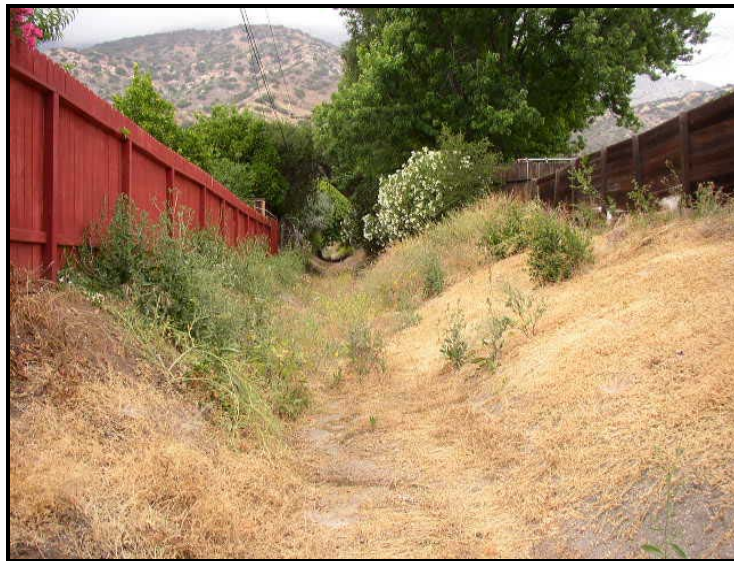
Photograph 24. Grandview-Park Drain showing Ruderal Grassland Series (27 May 2004).

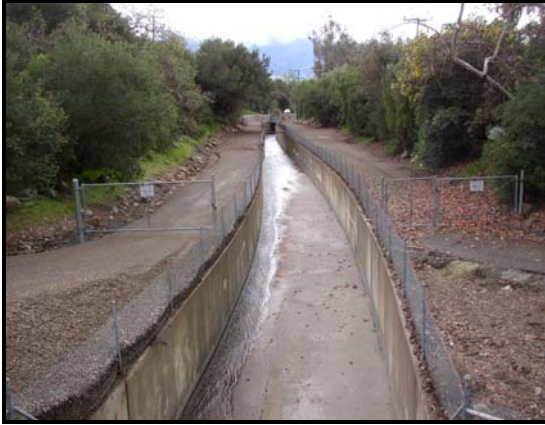
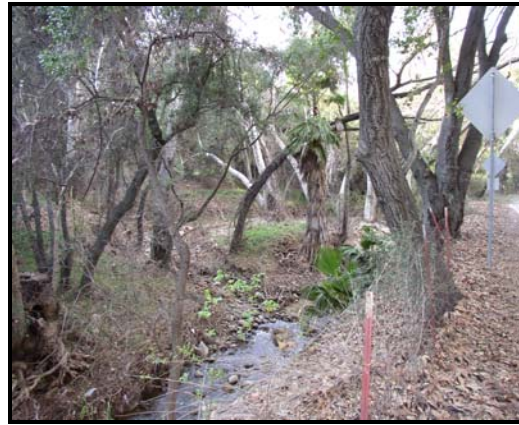
Photograph 28 (left). Upper end of Stewart Canyon Creek showing dense Coast Live Oak Series once continuous over the creek (28 January 2005). **Photograph 29** (right). Lower end of Stewart Canyon Creek showing an intermittent canopy (8 February 2005).

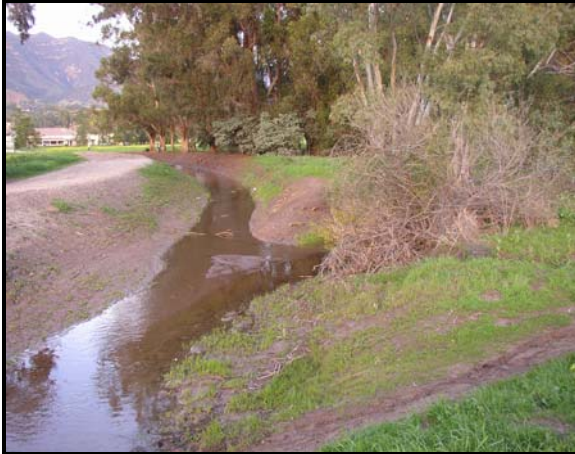
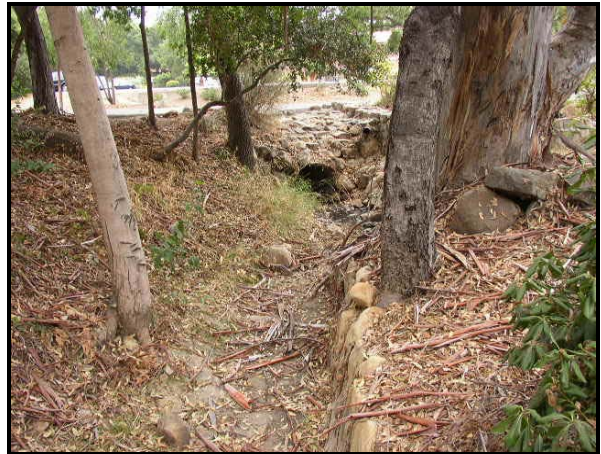
Photograph 30 (left). Nordhoff Drain and Happy Valley Drain confluence showing dense *Eucalyptus Series* in the background (15 January 2005). **Photograph 31** (right). Arbolada Creek showing how very little grows beneath *Eucalyptus Series* (30 September 2004).

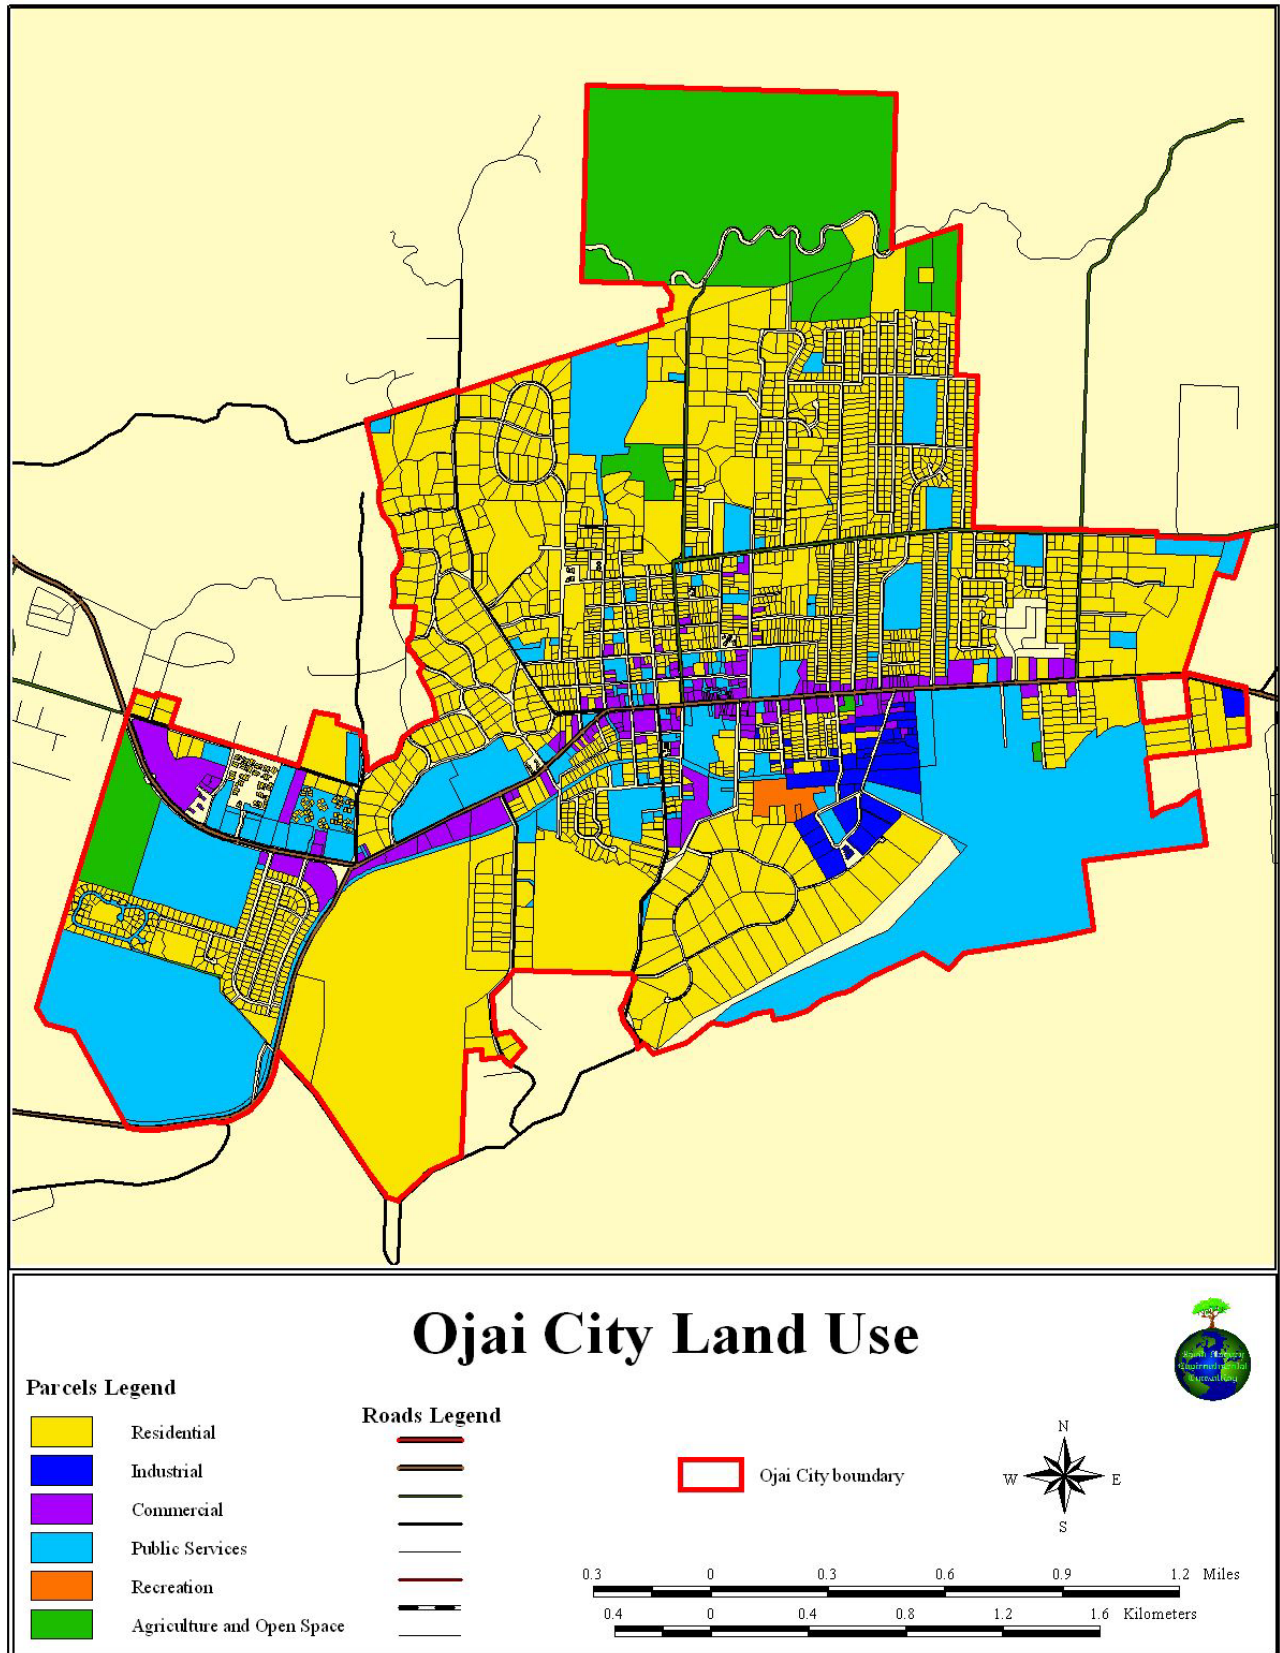
Figure 14. Map of Current and Planned Land Uses

Land use activities have decreased aquatic habitat quality throughout the City of Ojai. Most of the stream courses that pass through the City have been slightly to significantly altered, including undergrounding in long pipes and culverts. Many of the drainages flow through small urban residential properties with landowners causing (many unknowingly) direct and indirect adverse impacts to stream habitat and water quality. Many land uses immediately adjacent to “natural” drainages adversely impact stream habitats and water quality, such as placing horse corrals immediately adjacent to a stream. *Escherichia coli* (*E. coli*) bacteria contaminate surface waters and downstream aquatic habitats from surface runoff from such small corrals where buffers and filtering mechanisms are lacking. Numerous such conditions occur throughout the City’s drainages.

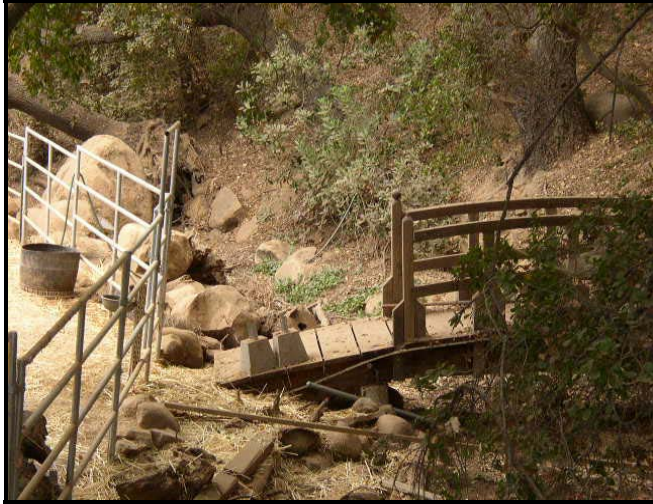
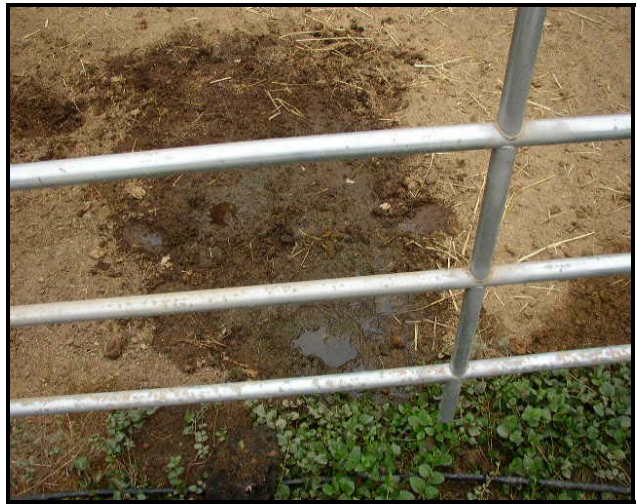
Photograph 41 (left). View of horse corral next to creek channel.
Photograph 42 (right). View of horse urine and manure within 25 feet of creek.

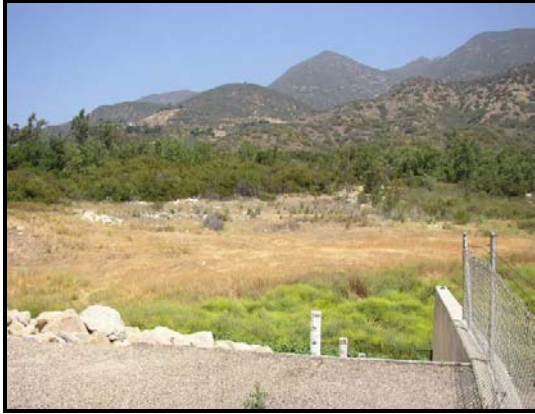
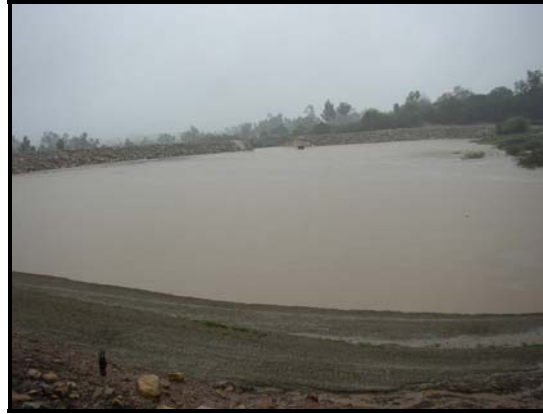
Photograph 49 (left). Stewart Canyon Debris Basin empty during spring and summer months (27 May 2004).
Photograph 50 (right). Stewart Canyon Debris Basin filled after winter storm event (9 January 2005).

Removing the debris dam is not considered an option since it provides important sediment control functions during large flood events, such as occurred in late December 2004 and January 2005, as shown on Photograph 50, Stewart Canyon Debris Basin filled by winter storm event (shown above in the San Antonio Creek Watershed Modifications subsection).

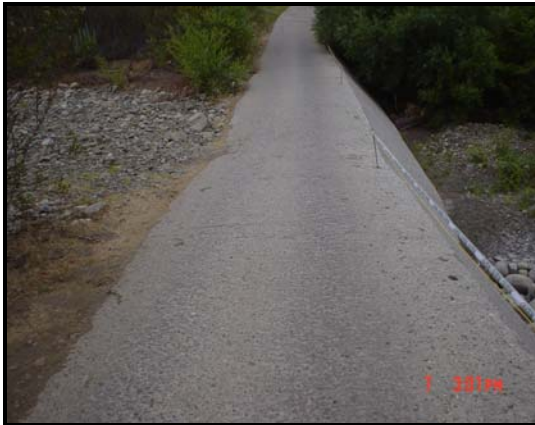
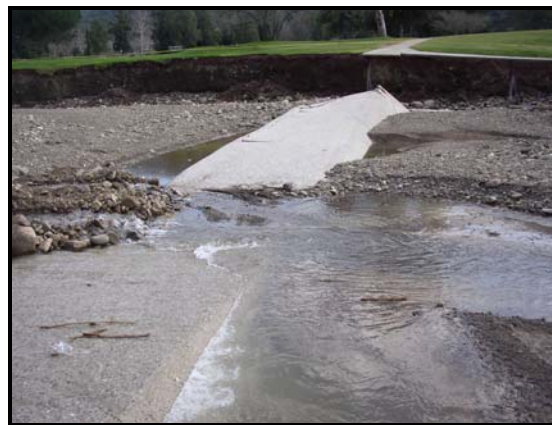
Photograph 51 (left). San Antonio Creek Arizona Crossing at Soule Park Golf Course creating a major barrier to Steelhead (16 July 2004). **Photograph 52** (right). San Antonio Creek Arizona Crossing at Soule Park Golf Course was washed out and buried by sediment during significant winter storm (8 February 2005).

One road-crossing barrier to fish passage occurs on San Antonio Creek at Soule Golf Course. This is the only significant road-crossing barrier within the City. However, the golf course is owned by the County of Ventura Parks Department, operated by a private concession. Several Southern Steelhead were trapped below this barrier in the spring of 1997-8, and failed to reach spawning habitat upstream. Soule Golf Course Arizona Road Crossing (Photographs 51 and 52 shown above in the San Antonio Creek Watershed Modifications subsection) is a barrier created on San Antonio Creek that effectively prevents Southern Steelhead from migrating to historic spawning grounds in the Ojai Valley and on Nordhoff Ridge.

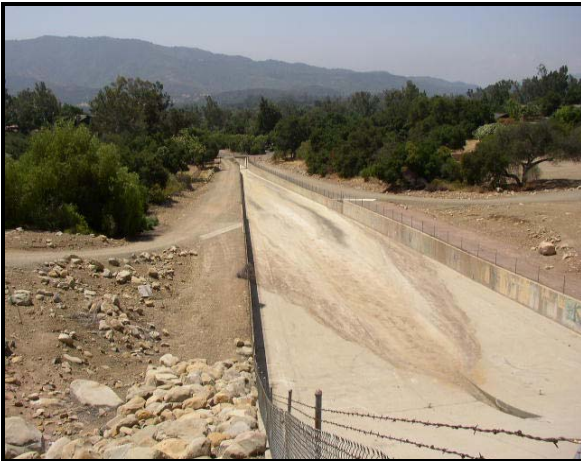
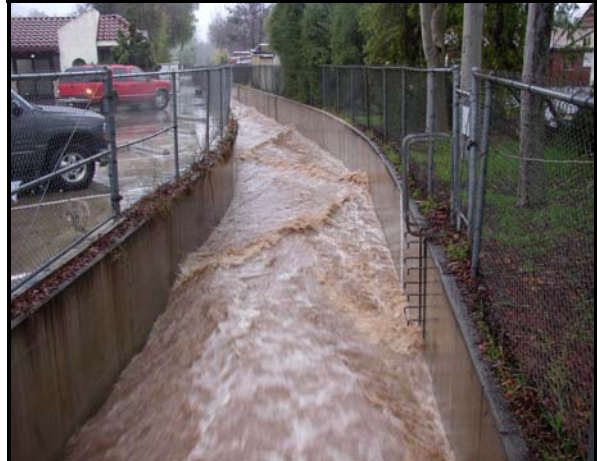
Photograph 53 (left). Stewart Canyon Creek showing aboveground flood control concrete channel (27 May 2004).
Photograph 54 (right). Fox Canyon Barranca showing meander pattern in concrete channel (9 January 2005).

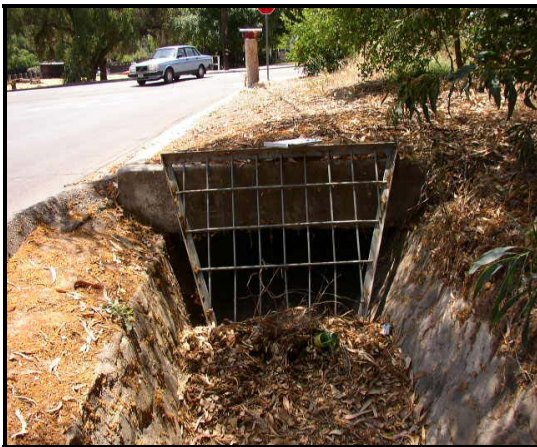
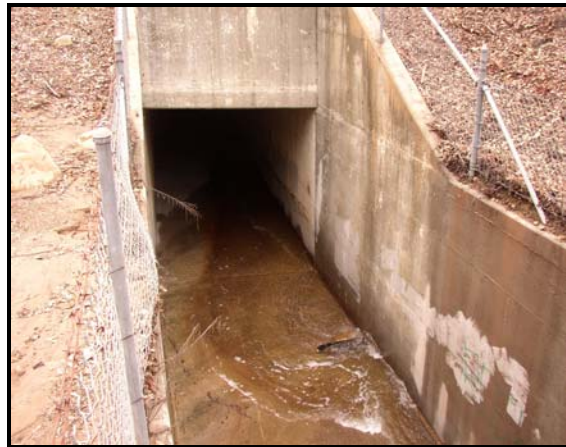
Photograph 55 (left). Undergrounding of Ojai Creek (27 May 2004). **Photograph 56** (right).
Undergrounding of Stewart Canyon Creek by a flood control channel and box culvert (8 January 2005).

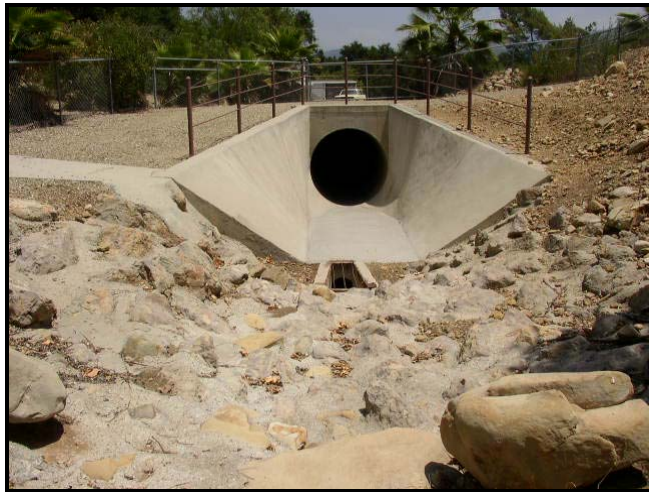
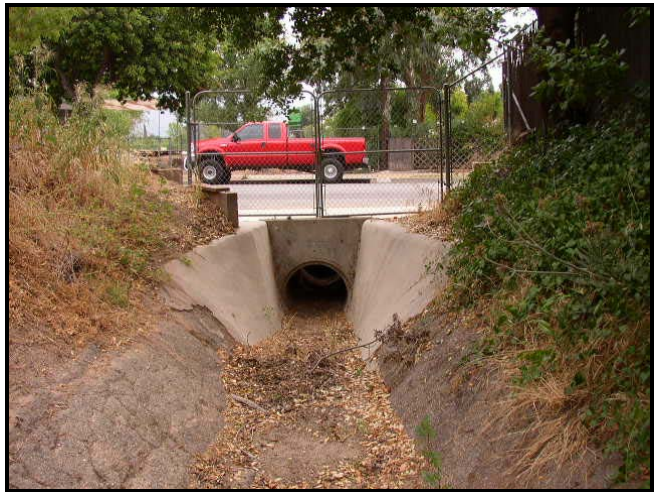
Photograph 59 (left). Fox Canyon Barranca underground intake (non-road) culvert, view downstream (27 May 2004).
Photograph 60 (right). Grandview-Park Drain road culvert (27 May 04).

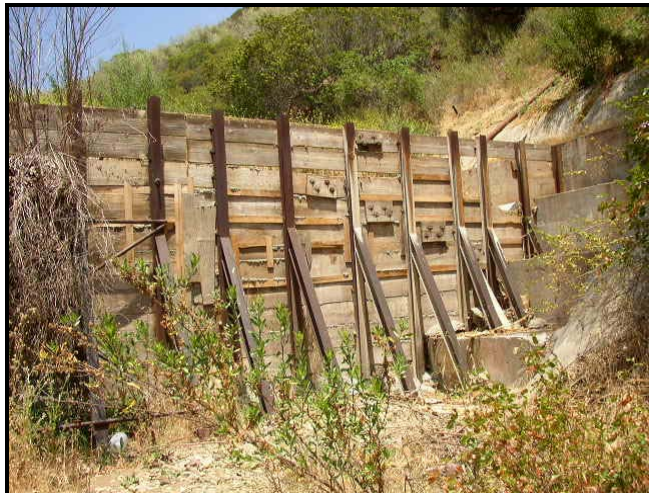
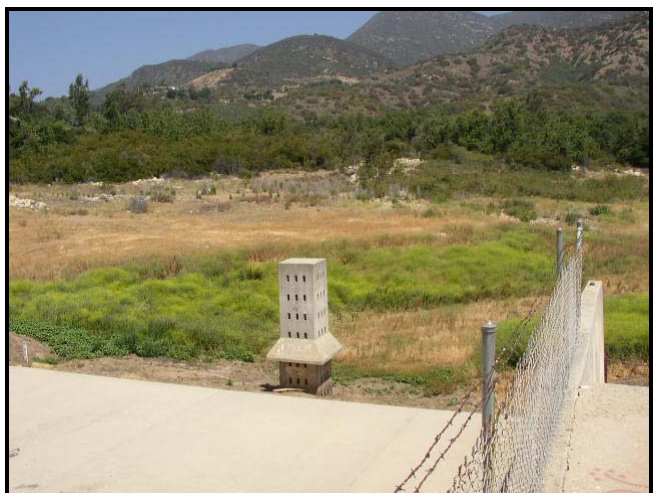
Some other barriers found throughout the City of Ojai include pipe diameter changes, upstream mitigation blockages, the Fox Canyon Barranca Debris Dam (Photograph 61), and Stewart Canyon Creek Debris Basin Standpipe (Photograph 62). These barriers are shown below in Figure 24, Map of Other Barriers in the City of Ojai.

Photograph 61 (left). Fox Canyon Barranca Debris Dam (27 May 2004).
Photograph 62 (right). Stewart Canyon Creek Debris Basin Standpipe (27 May 2004).

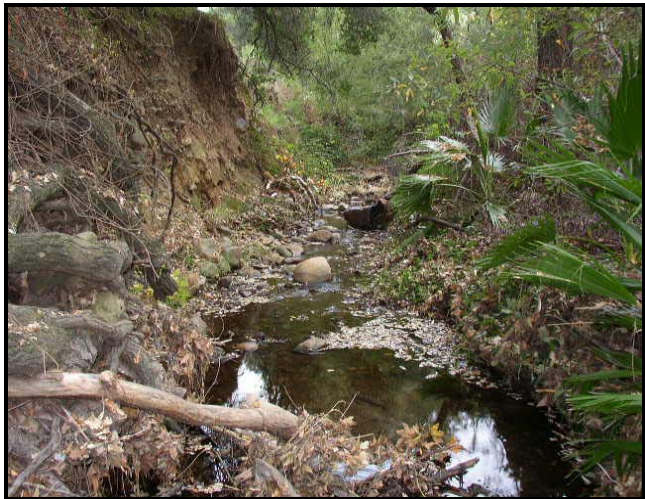
Reach 1 and 4 of Fox Canyon Barranca are determined to contain potential spawning and rearing habitat for Steelhead, based predominantly on good water quality and favorable riparian habitat, shading, and substrate; however, spawning and rearing are precluded by significant migration barriers (debris dam, long flat-bottomed concrete channel, and significant reaches mostly underground).

Photograph 69 (left). Fox Canyon Barranca Reach 1 above S. Ventura St. bridge (27 November 2004).

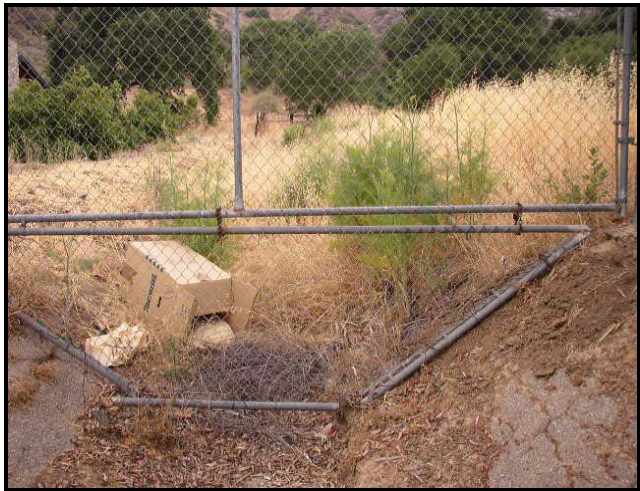
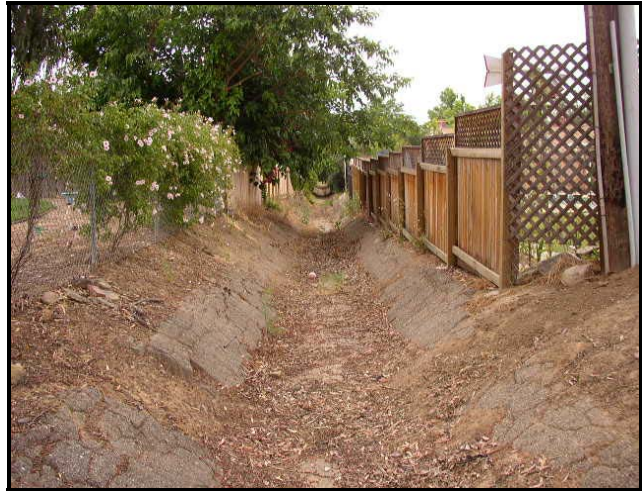
Grandview-Park Drain consists of two reaches. Reach 1 is below ground by an impervious reinforced concrete pipe (RCP) for a distance of 1,180 feet within the City limits. Reach 2 is an aboveground, impervious, concrete channel for a length of 2,980 feet. No water quality sampling was conducted in this creek. Grandview-Park Drain is an ephemeral drainage that is completely channelized with no natural surfaces. Instream cover, riparian habitat, and shading are all minimal. During the four months that water was present (January, March, October, and December), water velocity was slow and spawning and rearing substrate material is absent. Grandview-Park Drain does not contain potential spawning or rearing habitat for Steelhead.

*Photograph 71 (left). Grandview-Park Drain above housing tract.
Photograph 72 (right). Grandview-Park Drain near Topa Topa Elementary School. Photos taken 27 May 2004.*

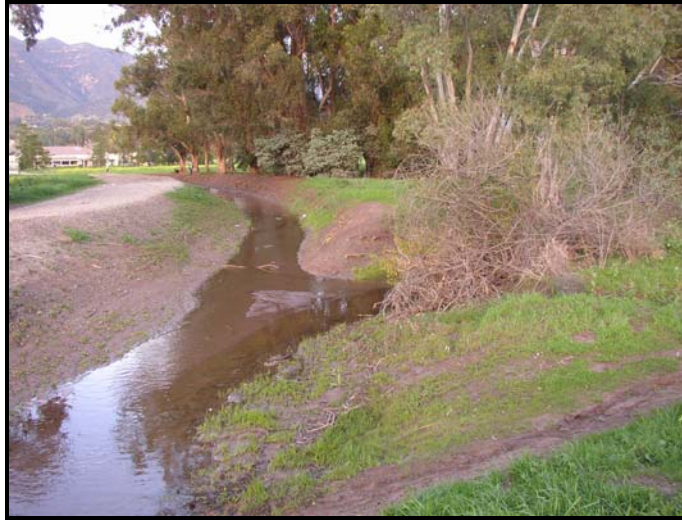
Nordhoff Drain consists of only one above ground reach with an all-natural substrate channel bottom for a length of approximately 837 feet within the City limits. No water quality sampling was conducted in this creek. Although this creek is an intermittent natural channel, it contains minimal instream cover and unsatisfactory riparian habitat and shading. Water flows six of the twelve months; however, when water is present, flow velocity is low and spawning and rearing substrate is absent. Since Nordhoff Drain does not contain satisfactory conditions for any of the vital parameters studied, this creek does not contain potential spawning and rearing habitat for Steelhead.

Photograph 73. Confluence of Happy Valley Drain (veering to the left) and Nordhoff Drain (veering to the right), view northeast (15 January 2005).

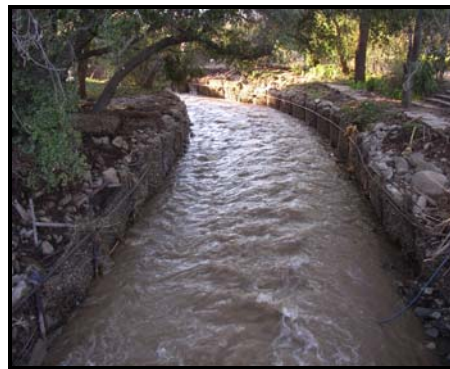
Thacher Creek is an intermittent creek channel with flows present only during the winter months. It contains natural channel morphology, adequate instream cover, satisfactory riparian plant communities, and suitable spawning and rearing substrate materials; however, due to the lack of flows throughout most of the year, Thacher Creek is not determined to contain potentially suitable habitat for Steelhead.

Photograph 84 (left). Thacher Creek below Boardman Road (9 January 2005).
Photograph 85 (right). Thacher Creek at Siete Robles Tract (12 January 2005).

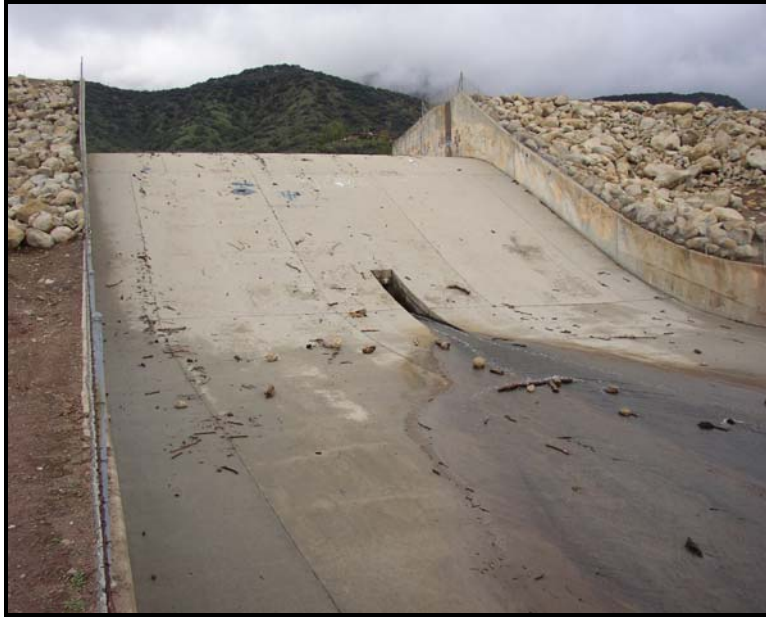
Since Stewart Canyon Creek provides the greatest amount of historic and suitable fish spawning and rearing habitat north of the City, fixing this barrier would provide the greatest benefit to Southern Steelhead. Constructing a fish ladder over the debris basin dam would be necessary to remove this barrier. Photograph 88, Stewart Canyon Debris Dam Spillway, illustrates the height and length of the spillway of the dam of this large debris basin. Southern Steelhead are not capable of swimming up this spillway into the debris basin when flows are sufficient for migration as the ramp is smooth concrete and too high to leap over. No plunge pool exists at the base of this spillway either.

Photograph 88. Stewart Canyon Debris Dam Spillway (28 January 2005).

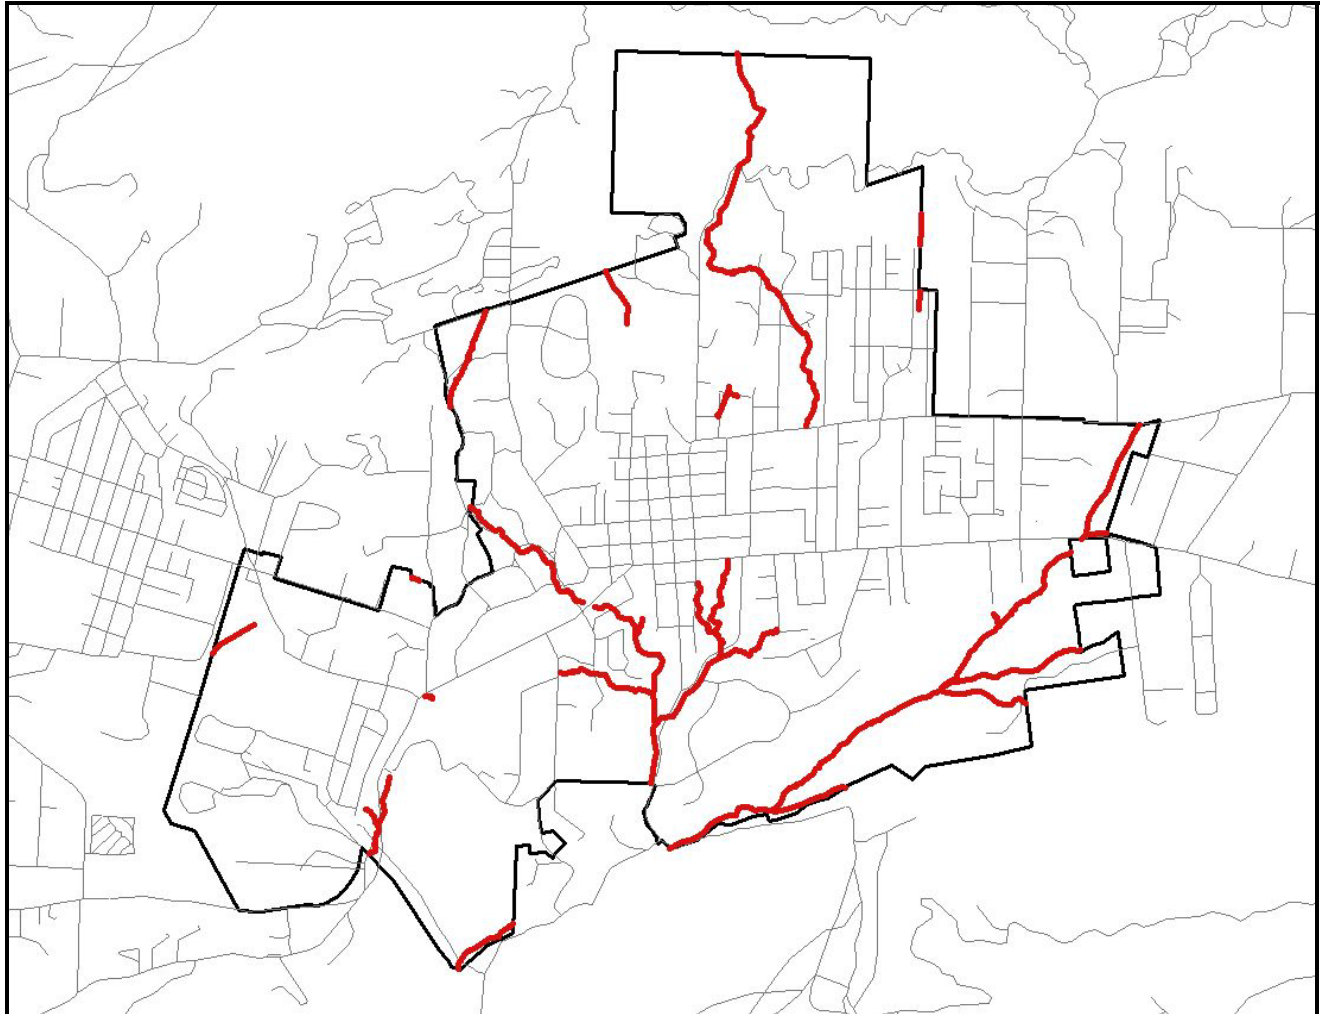
Figure 25. Map of Ojai Stream Reaches with Invasive Exotic Plants

The City should lead a project to remove invasive exotic plants from all streams within Ojai. Figure 25, Map of Ojai Stream Reaches with Invasive Exotic Plants, illustrates the portions of streams that flow through the City that contain significant amounts of invasive exotic plants that should be eradicated. Approximately 47,370 linear feet of streams within Ojai with a natural bed contain invasive exotic nonnative plants. These stream reaches can be made “weed free” fairly quickly as some reaches are only sparsely vegetated, or the number of invasive exotic plants is relatively low.

The red lines on this map indicate stream reaches within the City of Ojai that contain invasive exotic nonnative plants that should be targeted for weed eradication.

This effort should have two components, an initial eradication phase, and a maintenance phase. Once the streams have been eradicated of the existing invasive exotic plants, keeping them free of such pests should be a relatively small task. Work groups such as C.R.E.W. and the California Conservatoin Corps are well suited for taking on this project, in conjunction with nonprofit groups such as the California Native Plant Society, Audubon Society, Friends of the Ventura River, and Matilija Coalition.

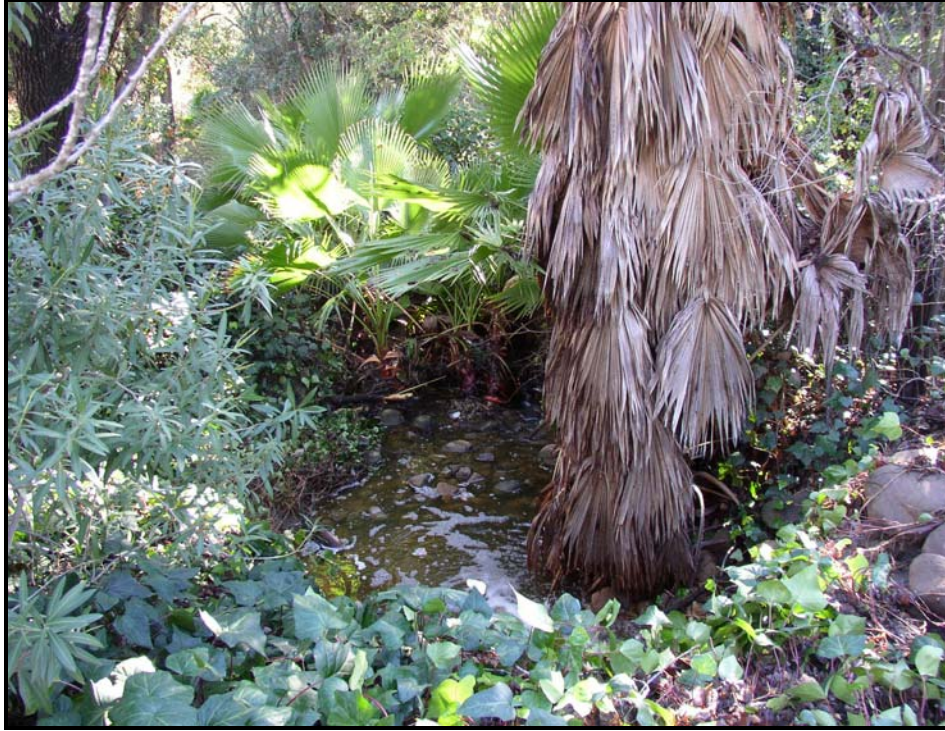
All City parks (Libbey Park) that contain streams should be maintained free of invasive exotic plants. Focus should be placed on removing the most aggressive and problematic non-native plants²⁴, such as: Mexican Fan Palm, Canary Island Date Palm, Tree-of-Heaven, River Red Gum, Spanish Broom, Giant Reed, Sweet Fennel, Periwinkle, Algerian Ivy, Morning-glory, and Smilo Grass (see Table 20 in the Existing Conditions section for a complete list of plants, including invasive exotics). The most regularly encountered invasive plant in the Ojai streams is the Mexican Fan Palm, some of which are 5 meters tall, but most are less than 1 meter high, as illustrated in Photograph 89, Mexican Fan Palm Invading Oak Creek, as well as Algerian Ivy.

Photograph 89. Mexican Fan Palm invading Oak Creek (11 January 2005).

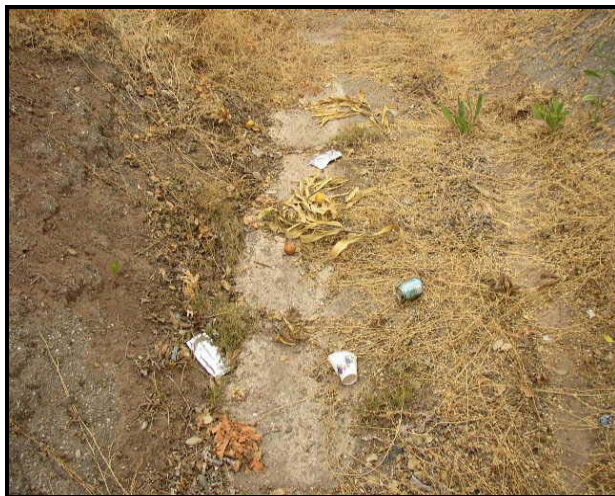
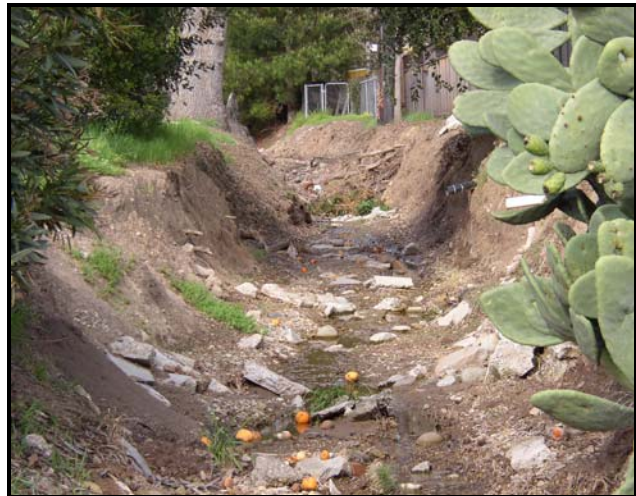
Photograph 90 (left). Trash in Grandview-Park Drain (27 May 2004).
Photograph 91 (right). Foreign material in Ayers Creek (8 February 2005).

The City should lead a project to remove all trash and debris that has been dumped or washed into the streams within Ojai, such as illustrated in Photographs 90 and 91 below. This effort should have two components, an initial clean-up phase, and a maintenance phase. Once the streams have been cleaned of the existing trash and debris, keeping them free of such trash should be a relatively simple (but labor-intensive) task if performed on a quarterly or biannual basis, annually at a minimum. Work groups such as C.R.E.W. and volunteer organizations such as Trout Unlimited and the Sierra Club are well suited for taking on this project, in conjunction with nonprofit groups such as the Lions Club and public and private school students. An annual creek cleanup day can be used to maximize public participation.

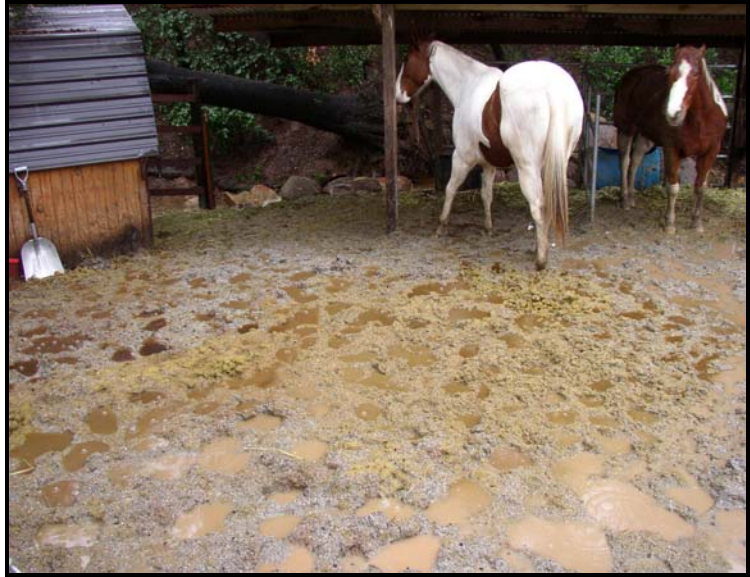
All stations sampled during 2004 and January 2005 were contaminated by *E. coli*. Sources of *E. coli* include fecal material from livestock, fowl, dogs, cats, and humans, as well as wild mammals. Domestic animals are the primary source in urban areas such as Ojai. This material enters Ojai streams from yards, street gutters, and corrals, unless the fecal material is properly disposed of into garbage bins or sewer lines. Photograph 92 (below) illustrates one example of a horse corral in close proximity to a creek within the City. Fecal material and urine from this small horse corral, and from similar situations elsewhere in the City, can easily enter the natural and man-made drainage systems within the City and introduce *E. coli* and other bacteria and viruses into the aquatic habitats downstream.

Photograph 92. Fecal material source contaminating a stream within the City of Ojai (8 January 2005).
