**CITY OF OJAI URBAN WATERSHED
ASSESSMENT AND RESTORATION PLAN**
(CDFG CONTRACT NO. PO250014)

August 2005

David Magney Environmental Consulting. 2005. City of Ojai Urban Watershed Assessment and Restoration Plan (CDFG Contract No. PO250014). 8 August 2005. (PN 02-0151.) Ojai, California. Prepared for the City of Ojai, California, and California Department of Fish and Game, Sacramento, California.

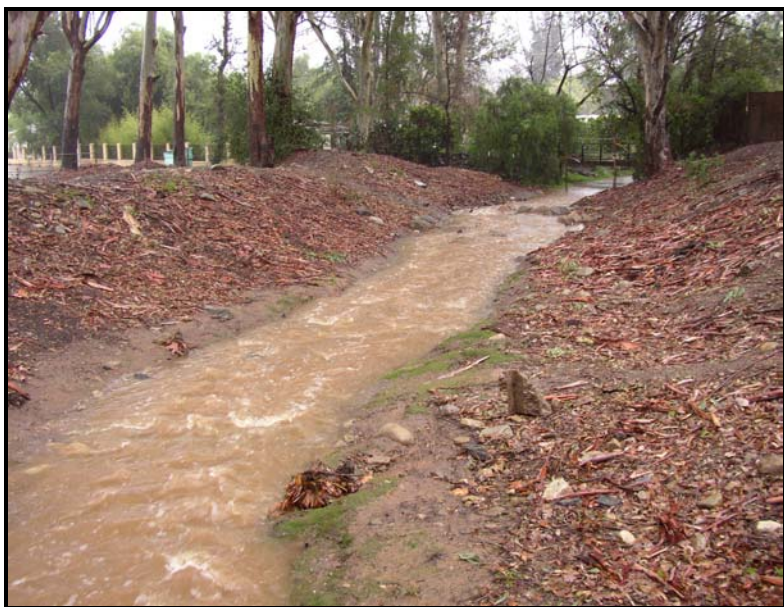
The upper reach of Ojai Creek just downstream of the bridge on Lion Street is an example of an ephemeral stream that generally lacks natural vegetation but has room for such planting, as illustrated on Photograph 93. Native riparian plants should be planted along the creek to provide: erosion control and bank stability, natural cover, shade, nesting sites, and structural diversity along this, and similar creeks within the city.

Photograph 93. Unvegetated and compacted channel of Ojai Creek (8 January 2005).

Many studies have shown that buffers between streams and urban land uses are most effective if they contain natural vegetation. The vegetation works hard to filter out pollutants, stabilize soil, and reduce erosion, as well as produce free atmospheric oxygen. A number of the drainages in Ojai lack vegetation, or any substantial amount of natural vegetation. The City could implement a program to plant native plants along existing drainages in public areas and easements, and provide guidance to property owners to do the same on private property.

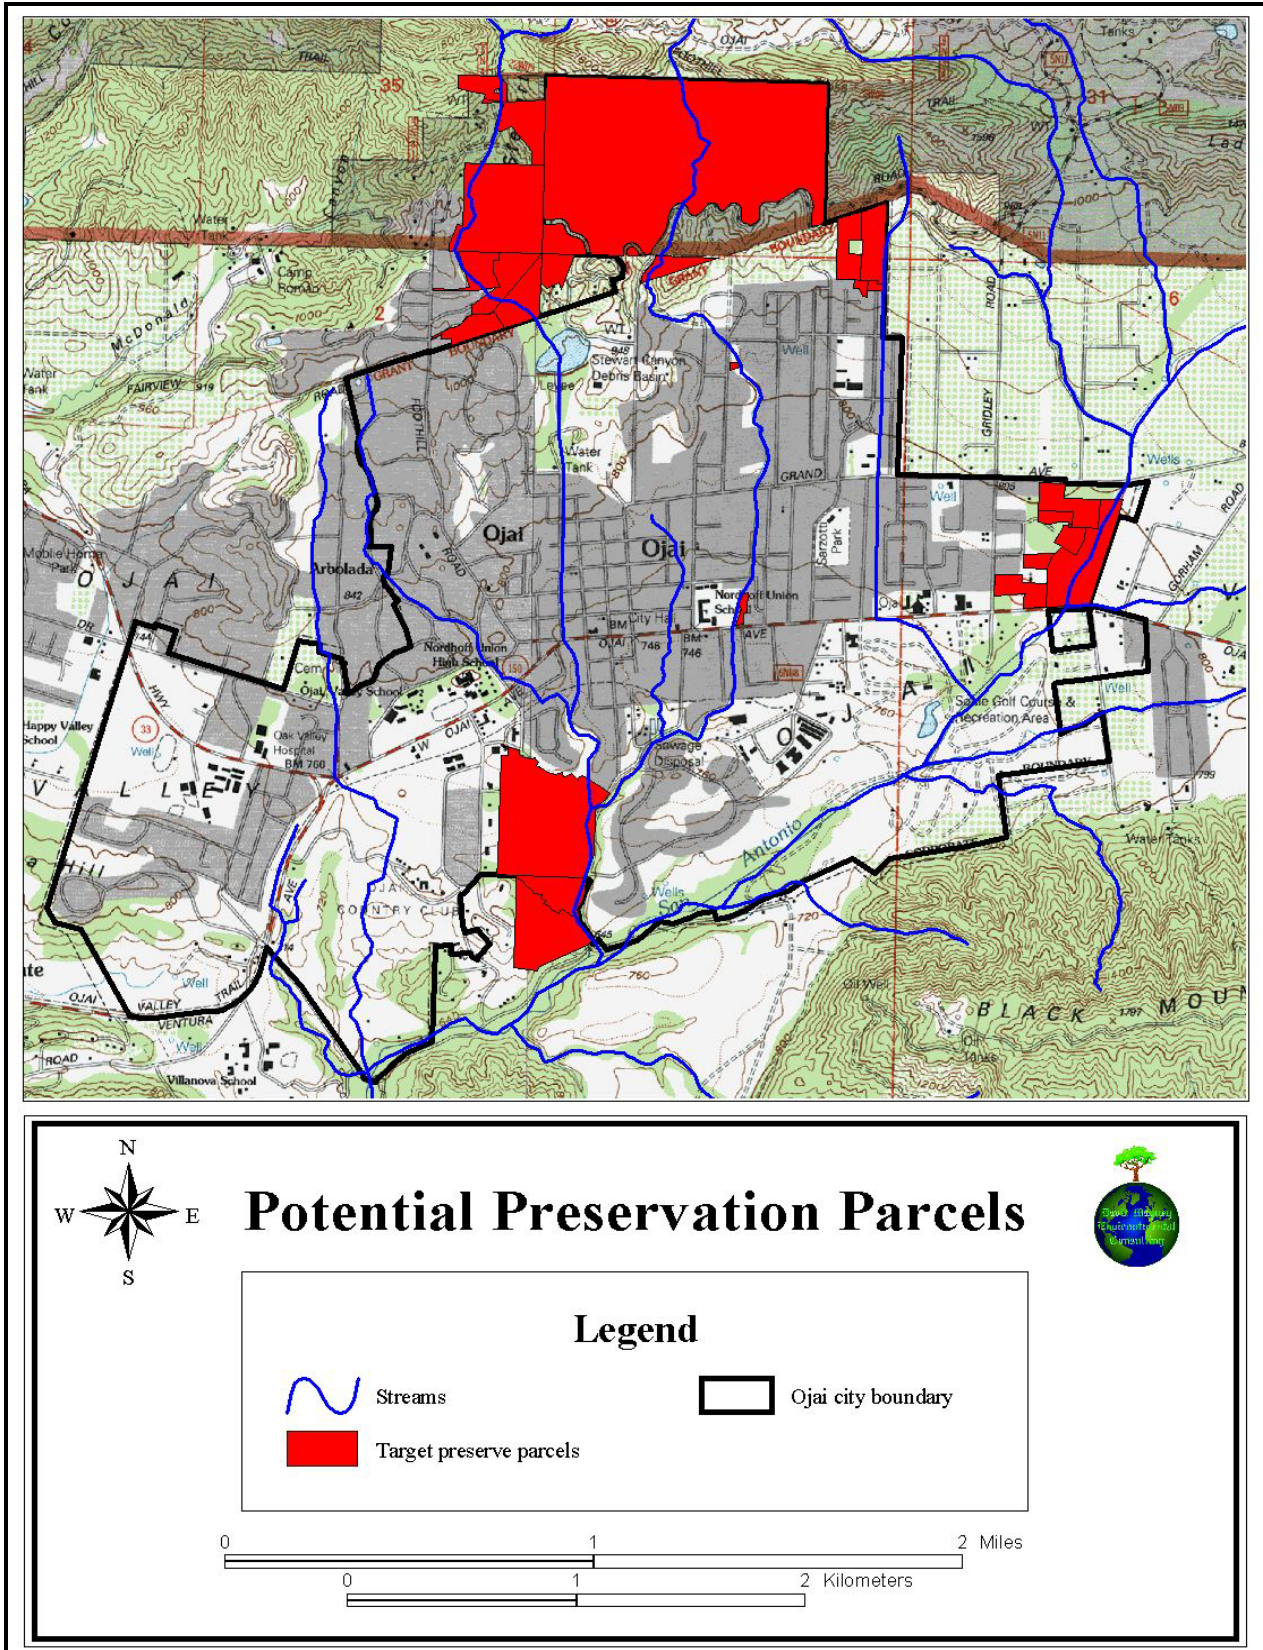
Figure 26. Map of Potential Preserve Parcels

Figure 26, Map of Potential Preserve Parcels, illustrates some of the parcels occurring within or adjacent to the City that are generally undeveloped and adjacent or including streams. None of these parcels are currently in public ownership and could be developed in the future. Preserving the natural vegetation on such parcels would benefit wetland functions and downstream water quality.
