# METHODS

## STREAM HABITAT CHARACTERIZATION

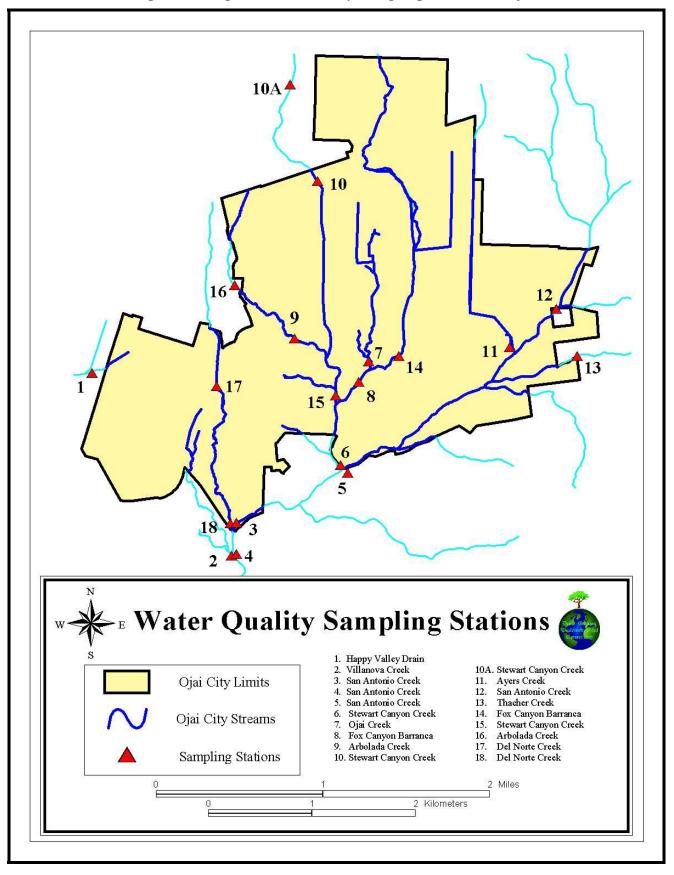
Figure 5. Map of Water Quality Sampling Stations in Ojai

Figure 5 provides the station locations as well as the streams studied for this project. Some creek/drainage names were invented for the sake of discussion. The station number, creek name, station location, and date sampled are listed in Table 5, Ojai Basin Streams Water Quality Sampling Sites, for each sampling station (following page).

Conventional field surveys were conducted to assess and characterize the stream habitats for the creeks shown in Figure 5, Map of Water Quality Sampling Stations. The portion of the watershed within the City of Ojai was analyzed for suitability of habitat for spawning, rearing, and migration for Southern Steelhead Trout by mapping and characterizing the instream and adjacent habitats along each stream within the City. Each stream was divided into reaches - based on habitat consistency, changes in those habitats, and fish barriers – and biologists walked the entire length of each stream to map, characterize, and assess their suitability for spawning, rearing, and migration for Steelhead.
